# FACILITY CONDITION ASSESSMENT

## TOWN OF ATKINSON

## COMMUNITY CENTER

February 5, 2020

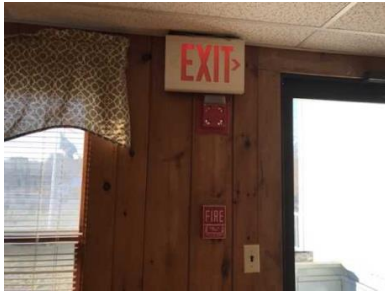
**Fire Alarm System in Poor condition.**

fire alarm fixtures are outdated and should be replaced for reliability - AssetCALC ID: 1711381

Uniformat Code: D5037  
Recommendation: **Upgrade/Install in 2020**

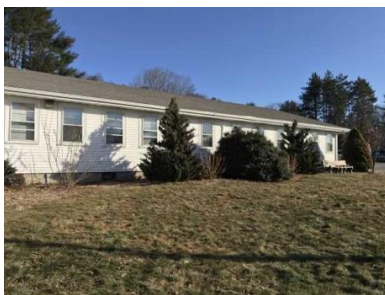
**Pedestrian Pavement in Poor condition.**

it is reported that a concrete path from the parking lot to the south entrance of the building is needed for pedestrians - AssetCALC ID: 1711434

Uniformat Code: G2031  
Recommendation: **Replace in 2020**

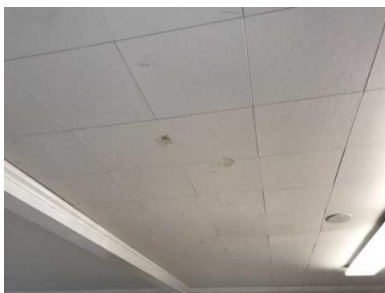
**Recommended Follow-up Study: Environmental, Asbestos (ACM) & Lead Base Paint (LBP)**

Suspect lead paint and asbestos containing ceiling tiles in the East building - AssetCALC ID: 1711405

Uniformat Code: P000X  
Recommendation: **Evaluate/Report in 2020**

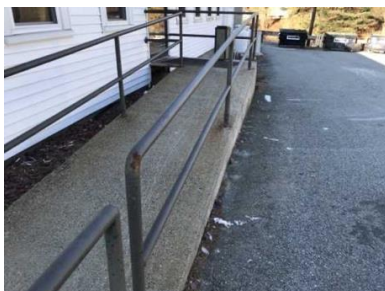
**Exterior Stair/Ramp Rails in Poor condition.**

railing is beginning to rust - AssetCALC ID: 1711355

Uniformat Code: B1015  
Recommendation: **Refinish in 2020**

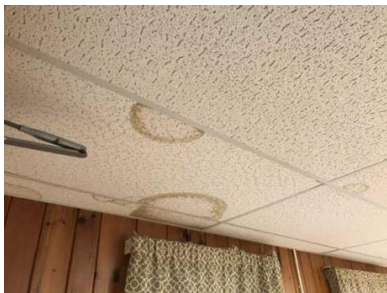
### Roof in Poor condition.

ceiling in recreation room corner next to kitchen leaks - AssetCALC ID: 1711976

Uniformat Code: B3011  
Recommendation: **Repair in 2020**

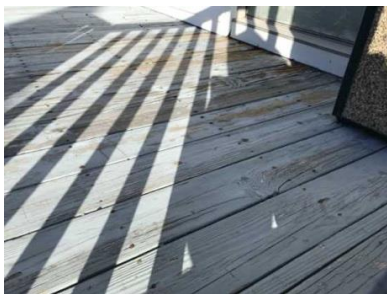
### Structural Flooring/Decking in Poor condition.

wood decking finish is faded and worn down, exposing the wood beneath - AssetCALC ID: 1711363

Uniformat Code: B1012  
Recommendation: **Refinish in 2020**

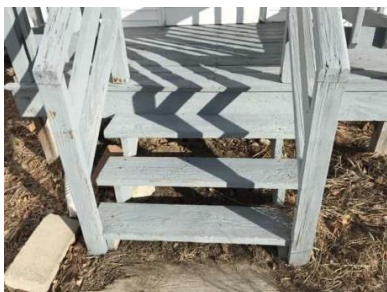
### Exterior Stairs in Poor condition.

exterior wooden stair finish is deteriorated - AssetCALC ID: 1711440

Uniformat Code: B1015  
Recommendation: **Refinish in 2020**

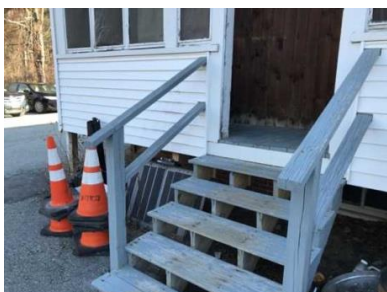
### Exterior Stair/Ramp Rails in Poor condition.

Railing finish is deteriorated, exposing wood underneath - AssetCALC ID: 1711368

Uniformat Code: B1015  
Recommendation: **Refinish in 2020**

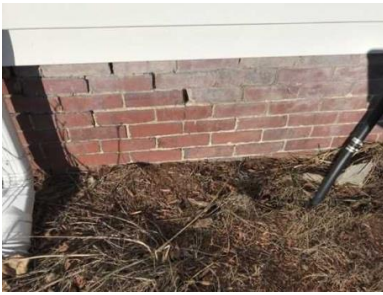
### Exterior Wall in Poor condition.

Deteriorating and loose mortar joints at brick and CMU foundational wall - AssetCALC ID: 1711435

Uniformat Code: B2011  
Recommendation: **Repair/Repoint in 2020**

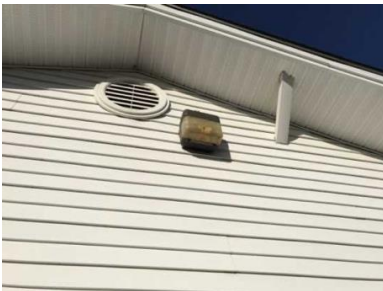
### Light Fixture in Poor condition.

light fixture is cracked and aged - AssetCALC ID: 1711366

Uniformat Code: D5022  
Recommendation: **Replace in 2020**

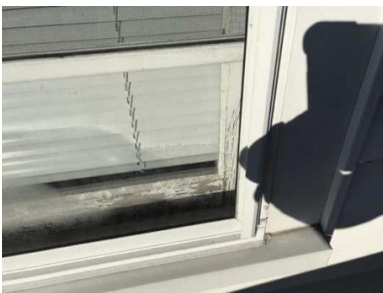
### Window in Poor condition.

7 wood framed window replacements planned for 2020 - AssetCALC ID: 1713273

Uniformat Code: B2021  
Recommendation: **Replace in 2020**

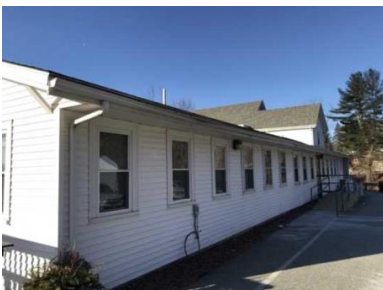
### Gutters & Downspouts in Poor condition.

gutter is damaged - AssetCALC ID: 1711431

Uniformat Code: B3016  
Recommendation: **Replace in 2020**

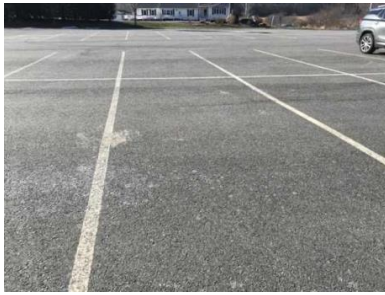
### Parking Lots in Poor condition.

Sealant is faded and parking stripes beginning to fade in asphalt lot - AssetCALC ID: 1711378

Uniformat Code: G2022  
Recommendation: **Seal & Stripe in 2021**

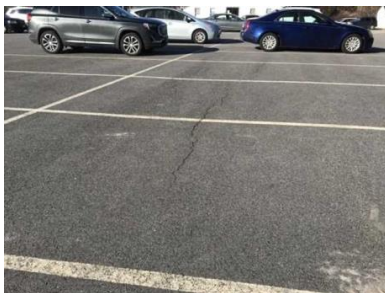
### Parking Lots in Poor condition.

cracking in areas of newer asphalt lot - AssetCALC ID: 1711438

Uniformat Code: G2022  
Recommendation: **Cut & Patch in 2020**

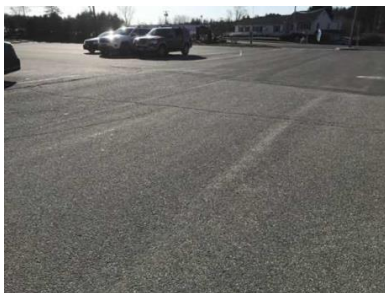
### Parking Lots in Poor condition.

parking lot has severe alligator cracking - AssetCALC ID: 1711415

Uniformat Code: G2022  
Recommendation: **Mill & Overlay in 2021**

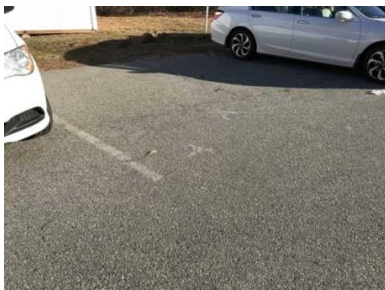
### Parking Lots in Poor condition.

sealant and parking stripes are faded - AssetCALC ID: 1711375

Uniformat Code: G2022  
Recommendation: **Seal & Stripe in 2021**

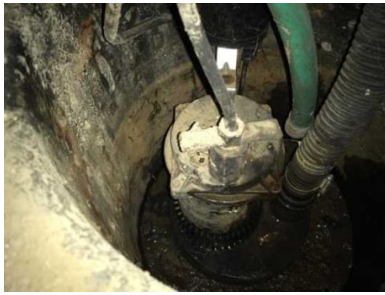
### Sump Pump in Poor condition.

sump pump is aged and rusting - AssetCALC ID: 1711430

Uniformat Code: D2043  
Recommendation: **Replace in 2020**

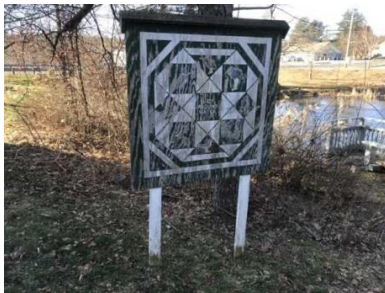
### Signage in Poor condition.

signage at pond is deteriorated/ illegible - AssetCALC ID: 1711441

Uniformat Code: G2044  
Recommendation: **Replace/Install in 2021**

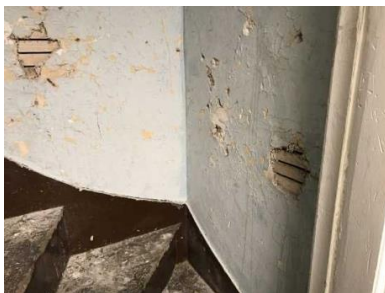
### Interior Wall Construction in Poor condition.

plaster in attic is in broken/ deteriorated condition - AssetCALC ID: 1711382

Uniformat Code: C1011  
Recommendation: **Replace in 2020**

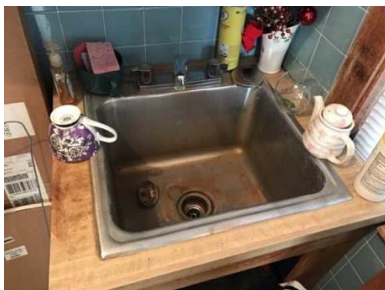
### Sink/Lavatory in Poor condition.

Sink is heavily rusting - AssetCALC ID: 1711409

Uniformat Code: D2014  
Recommendation: **Replace in 2020**

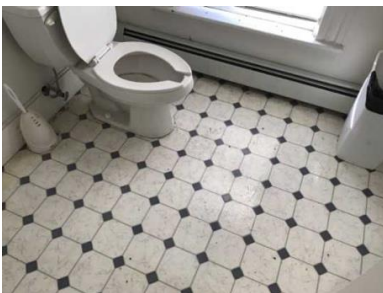
**Interior Floor Finish in Poor condition.**

vinyl sheeting is worn and stained - AssetCALC ID: 1711410

Uniformat Code: C3024  
Recommendation: **Replace in 2021**

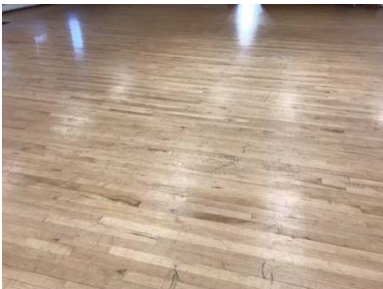
**Interior Floor Finish in Poor condition.**

floor finish is heavily scuffed and worn down - AssetCALC ID: 1711388

Uniformat Code: C3024  
Recommendation: **Refinish in 2021**

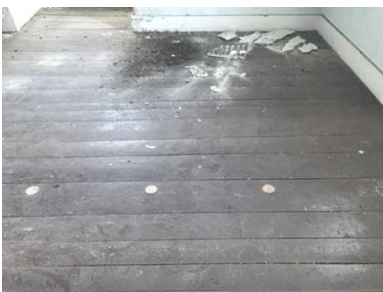
**Interior Floor Finish in Poor condition.**

wood flooring finish is deteriorated - AssetCALC ID: 1711412

Uniformat Code: C3024  
Recommendation: **Refinish in 2020**

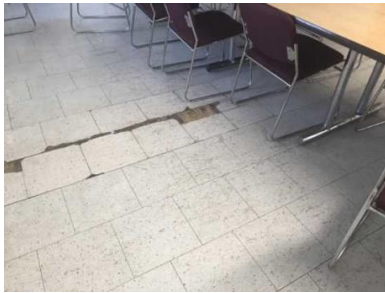
### Interior Floor Finish in Poor condition.

VCT is aged, scuffed and breaking throughout - AssetCALC ID: 1711385

Uniformat Code: C3024  
Recommendation: **Replace in 2020**

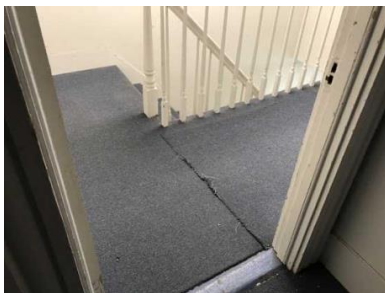
### Interior Floor Finish in Poor condition.

carpet is aged and worn - AssetCALC ID: 1711432

Uniformat Code: C3025  
Recommendation: **Replace in 2022**

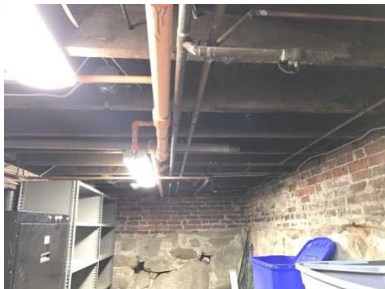
### Interior Wall Finish in Poor condition.

Areas of loose and deteriorating mortar joints in the west house basement brick/ masonry walls - AssetCALC ID: 1713327

Uniformat Code: C3012  
Recommendation: **Repair in 2020**

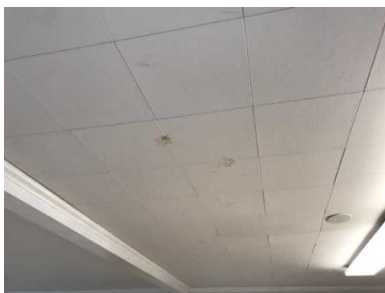
### Interior Ceiling Finish in Poor condition.

tiles are aged, in deteriorating condition and are suspected to contain asbestos - AssetCALC ID: 1711356

Uniformat Code: C3032  
Recommendation: **Replace in 2021**

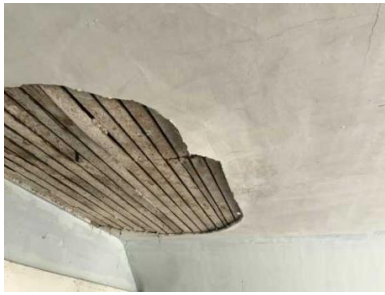
### Interior Ceiling Finish in Poor condition.

plaster ceiling is broken/ missing - AssetCALC ID: 1711392

Uniformat Code: C3031  
Recommendation: **Replace in 2020**

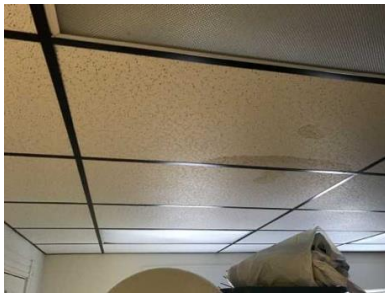
### Interior Ceiling Finish in Poor condition.

ACT has stains and broken/ missing panels - AssetCALC ID: 1711420

Uniformat Code: C3032  
Recommendation: **Replace in 2020**

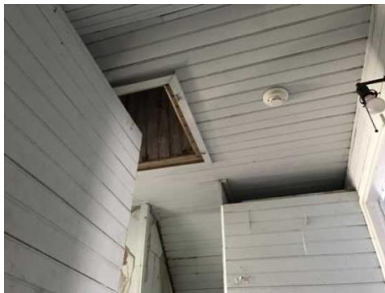
### Interior Ceiling Finish in Poor condition.

ceiling in attic should be painted after new plaster/ drywall is installed - AssetCALC ID: 1711353

Uniformat Code: C3031  
Recommendation: **Prep & Paint in 2020**

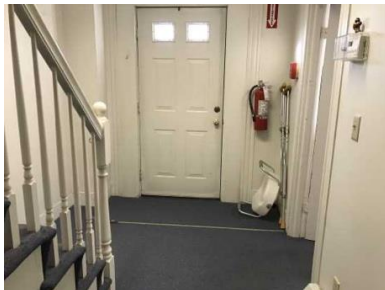
### Interior Wall Finish in Poor condition.

painted wall finish is stained or chipped - AssetCALC ID: 1711400

Uniformat Code: C3012  
Recommendation: **Prep & Paint in 2020**

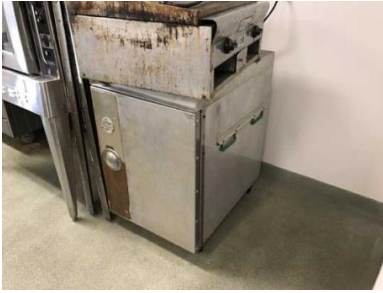
## Commercial Kitchen in Poor condition.

food warmer is aged and in deteriorating condition - AssetCALC ID: 1711387

Recommendation: **Replace in 2020**

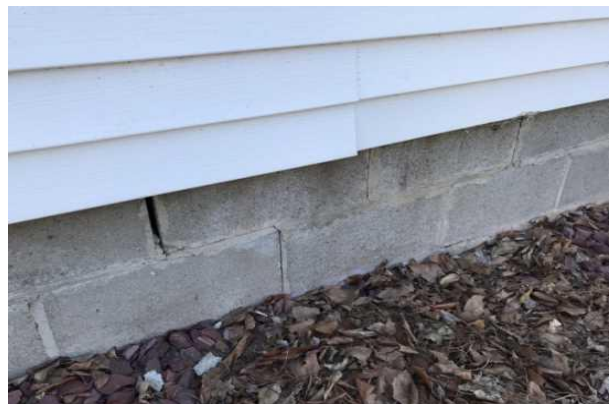
#18 CMU SUBSTRUCTURE, LOOSE MORTAR JOINTS
