FACILITY CONDITION ASSESSMENT

TOWN OF ATKINSON

FIRE STATION

1 ACADEMY AVENUE
ATKINSON, NEW HAMPSHIRE 03812

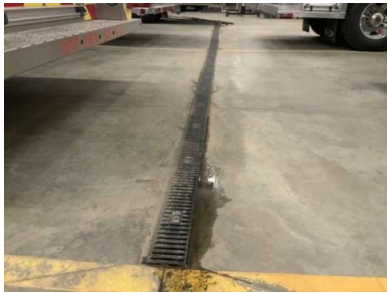
Interior Floor Finish in Poor condition.

Concrete
Fire Station Bay Area

Regrade - AssetCALC ID: 1705662

Uniformat Code: C3021
Recommendation: **Repair in 2020**

C3021	1705662	Interior Floor Finish, Concrete, Repair	0	0	0	60	SF	\$30.00	\$1,800	\$1,800																					\$1,800
C3024	1692460	Interior Floor Finish, Vinyl Tile (VCT), Replace	15	8	7	10820	SF	\$5.00	\$54,100								\$54,100														\$54,100
C3025	1692529	Interior Floor Finish, Carpet Commercial Standard, Replace	10	5	5	2705	SF	\$7.50	\$20,288						\$20,288										\$20,288						\$40,575
C3032	1692476	Interior Ceiling Finish, Suspended Acoustical Tile (ACT), Replace	25	20	5	10820	SF	\$3.50	\$37,870						\$37,870																\$37,870
D1011	1692524	Elevator, 1400 LB, Renovate	30	20	10	1	EA	\$55,000.00	\$55,000											\$55,000											\$55,000
D2011	1692443	Toilet, GPF, Replace	30	20	10	5	EA	\$1,300.00	\$6,500											\$6,500											\$6,500
D2012	1692509	Urinal, GPF, Replace	30	20	10	3	EA	\$600.00	\$1,800											\$1,800											\$1,800
D2014	1692451	Sink/Lavatory, Wall-Hung, Vitreous China, Replace	30	20	10	1	EA	\$1,500.00	\$1,500											\$1,500											\$1,500

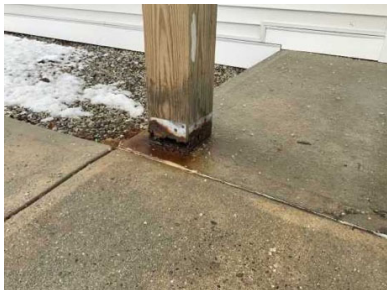
Structural Frame in Poor condition.

Fire Station Building exterior

Deteriorating - AssetCALC ID: 1692488

Uniformat Code: B101X
Recommendation: **in 2020**

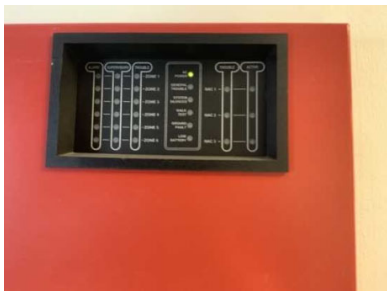
Fire Alarm Control Panel

Addressable
Fire Station 1st Floor

original to construction and should be replaced for reliability. - AssetCALC ID: 1701361

Uniformat Code: D5037
Recommendation: **Replace in 2020**
