FACILITY CONDITION ASSESSMENT

TOWN OF ATKINSON

HISTORICAL SOCIETY

3 Academy Avenue
Atkinson, New Hampshire 03811

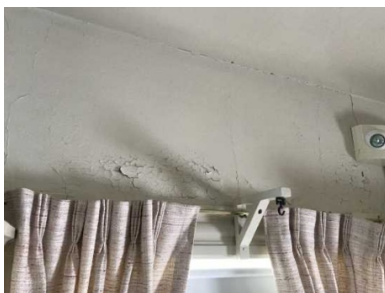
**Recommended Follow-up Study: Environmental, Sample for Lead Paint**

Old and cracking paint suggests the possible presence of Lead paint. Samples should be taken to determine the presence of lead - AssetCALC ID: 1698845

Uniformat Code: P000X
Recommendation: **Evaluate/Report in 2020**

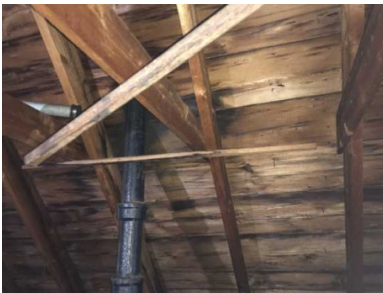
Pipe & Fittings in Poor condition.

Cast-iron ventilation piping is being poorly supported in the attic, should be replaced with PVC - AssetCALC ID: 1701416

Uniformat Code: D2021
Recommendation: **Replace in 2020**

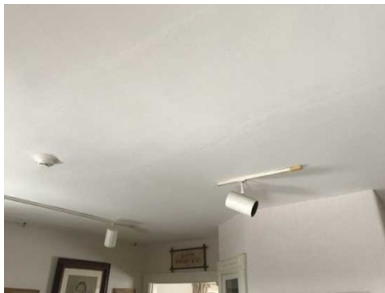
Interior Ceiling Finish in Poor condition.

Interior finish stained and fading. requires refinish after mortar is repaired - AssetCALC ID: 1698825

Uniformat Code: C3031
Recommendation: **Prep & Paint in 2021**

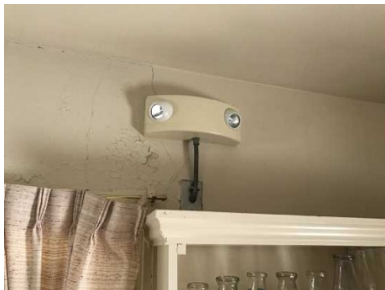
Interior Wall Finish in Poor condition.

Paint is peeling, cracked and stained. Should be refinished after repair of plaster - AssetCALC ID: 1698785

Uniformat Code: C3012
Recommendation: **Prep & Paint in 2020**

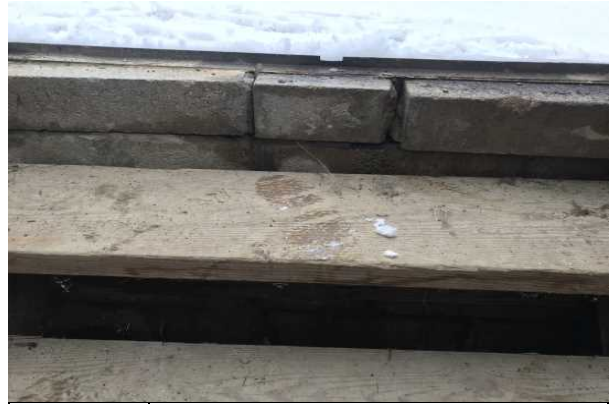
#14

BULKHEAD CMU WALL,
DETERIORATING MORTAR
JOINTS

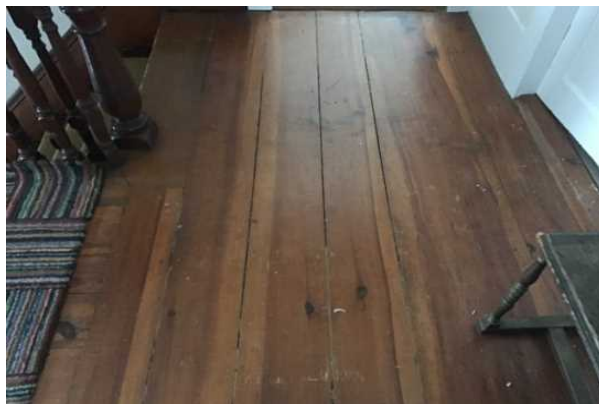
#41

INTERIOR FLOOR FINISH, WOOD
STRIP, REFINISH

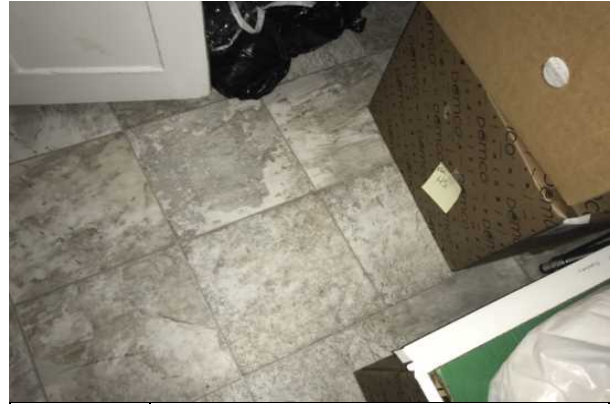
#44

INTERIOR FLOOR FINISH, VINYL
SHEETING, REPLACE
