FACILITY CONDITION ASSESSMENT

LIBRARY

5 Academy Avenue
Atkinson, New Hampshire 03813

January 31, 2020

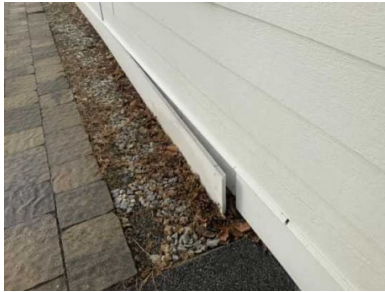
Exterior Wall in Poor condition.

Wood Clapboard Siding, 1-2 Stories
Library Building exterior

Deteriorating siding from water infiltration, roof don and apos;t have drainage system. - AssetCALC ID: 1700117

Uniformat Code: B2011
Recommendation: **Repair in 2020**

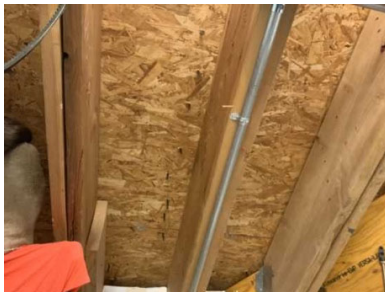
Roof in Poor condition.

any type per man-day
Library Attic

Anchors not attached to truss in attic - AssetCALC ID: 1700171

The structure is in poor condition due to incorrect installation. The roof truss is not attached to supporting nails and exterior siding needs fastening. A professional structural engineer must be retained to analyze the existing condition, provide recommendations and, if necessary, estimate the scope and cost of any required repairs. The cost of this study is included in the cost tables.

Uniformat Code: B3011
Recommendation: **Repair in 2020**

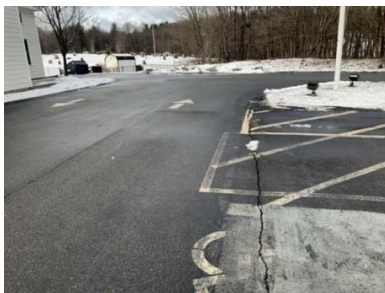
The asphalt pavement has faded seal and stripe, replacement is recommended as it has reached its expected life span. The asphalt pavement also has a crack due to deterioration; cutting a patching the asphalt is recommended.

Parking Lots in Poor condition.

Library Site

Cracked Asphalt- seal and amp; coil is recommended - AssetCALC ID: 1700767

Uniformat Code: G2022
Recommendation: **Cut and Patch in 2020**

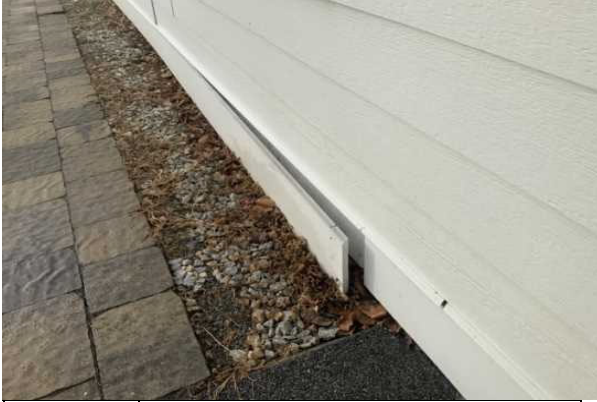
#7

SIDING-ISSUE

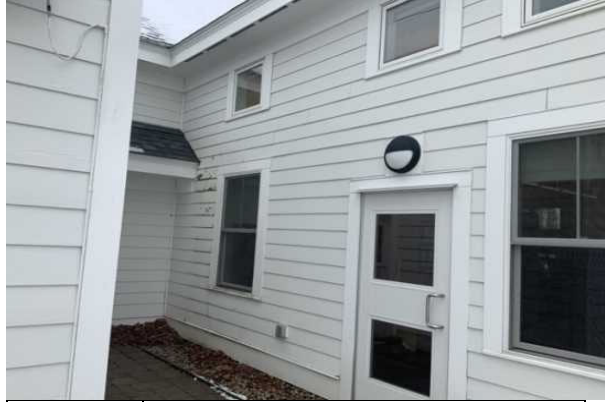
#8

SIDING-ISSUE

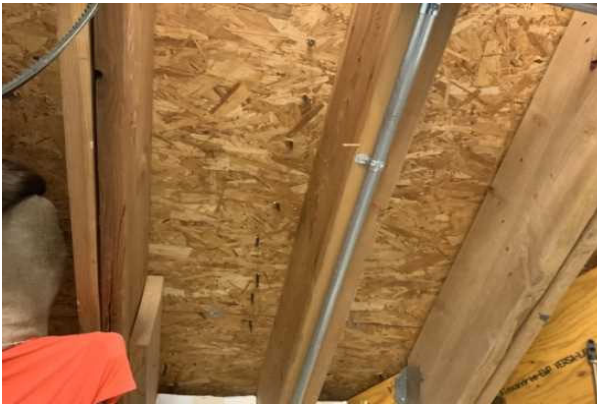
#9

ROOF/TRUSS- ISSUE
