FACILITY CONDITION ASSESSMENT

TOWN OF ATKINSON

POLICE DEPARTMENT

27 Academy Avenue
Atkinson, NH 03811

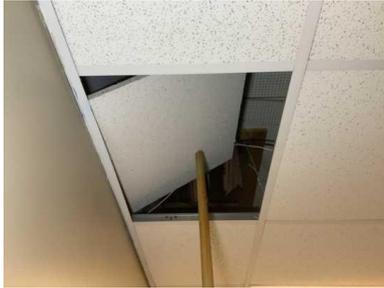
Recommended Follow-up Study: Structural, General Design

Structural, General Design
Police Station Throughout building

There have been environmental concerns over the years, previous stair case was removed and attic space needs to be reviewed structurally for integrity before building can be repurposed. In addition, inspect rafters and decking for reasons why moisture has highlighted trusses in attic space, see photo. - AssetCALC ID: 2235367

Uniformat Code: P2032
Recommendation: **Perform Study in 2020**

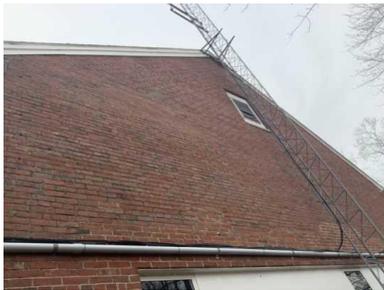
Exterior Walls in Poor condition.

Brick, 1-2 Story Building
Police Station Building exterior

Mortar is missing in several joints between bricks - AssetCALC ID: 2235378

| UF Code | Location | Condition | Asset/Component/Repair | Quantity | RUL | ID |
|---|---|---|---|---|---|---|
| B2010 | Building exterior | Poor | Exterior Walls, Brick, 1-2 Story Building, Repair | 500 SF | 0 | 2235378 |

Uniformat Code: B2011
Recommendation: **Repair in 2020**

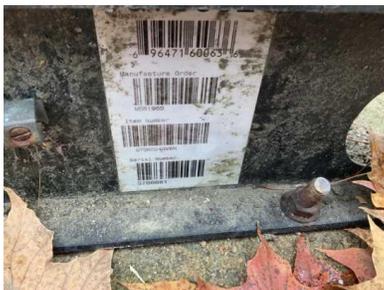
Generator in Poor condition.

Gas or Gasoline, 25 to 35 KW
Police Station Site

Unit doesn't run reliably when needed - AssetCALC ID: 2235376

Uniformat Code: D5011
Recommendation: **Replace in 2020**

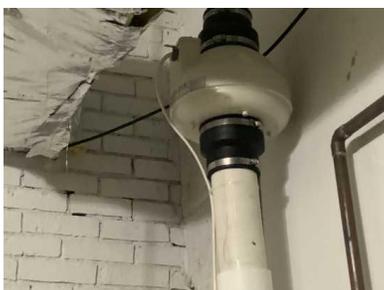
Exhaust Fan in Failed condition.

Centrifugal, 12" Damper, 100 to 1000 CFM
Police Station Mechanical room

Radon system is currently not functioning - AssetCALC ID: 2235375

| UF Code | Location | Condition | Asset/Component/Repair | Quantity | RUL | ID |
|---|---|---|---|---|---|---|
| D3060 | Mechanical room | Failed | Exhaust Fan, Centrifugal, 12" Damper, 100 to 1000 CFM | 1 | 0 | 2235375 |

Uniformat Code: D3063
Recommendation: **Replace in 2020**

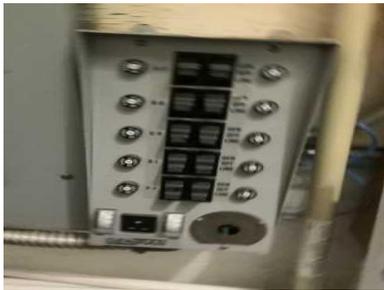
Distribution Panel in Poor condition.

120/240 V, Residential Style
Police Station Mechanical room

Uniformat Code: D5023
Recommendation: **Replace in 2020**

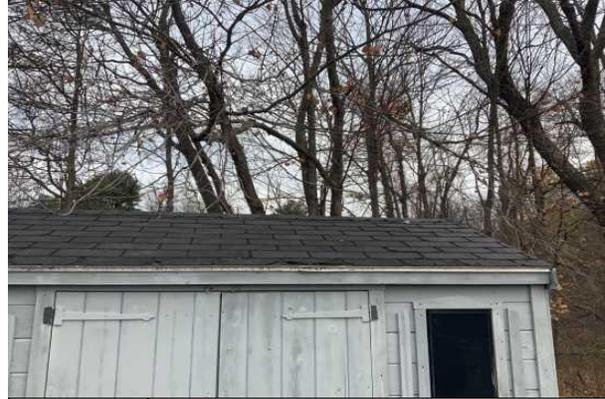
| 14 | SHED ROOF |

The parking lot is in generally good condition for its present use. The sheds will need attention soon, especially regarding their roofs.
