# FACILITY CONDITION ASSESSMENT

## TOWN OF ATKINSON

## TOWN GARAGE

January 30, 2020

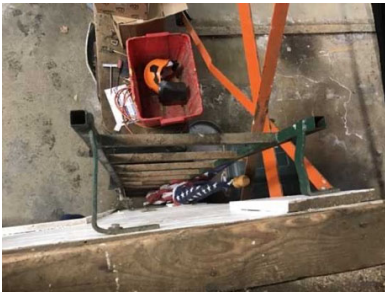
**Roof Access Ladder in Poor condition.**

Steel  
Town Garage Garage

access ladder rusted/ warping at fastener - AssetCALC ID: 1689915

Uniformat Code: B1029  
Recommendation: **Replace in 2020**

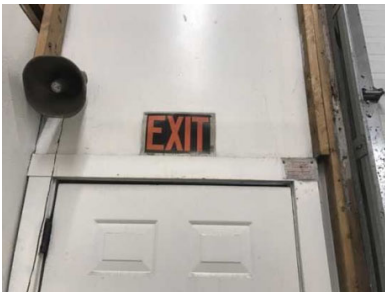
**Exit Sign Light Fixture**

LED exit sign should be installed - AssetCALC ID: 1689909

Uniformat Code: D5092  
Recommendation: **Replace in 2020**

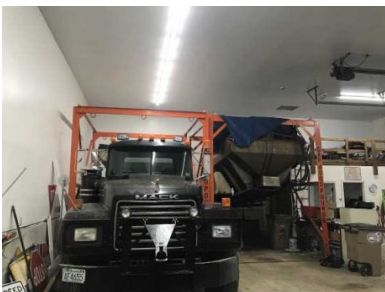
**Exhaust Fan Install**

No powered ventilation in garage. POC reports that exhaust buildup from vehicles in garage has become a safety concern - AssetCALC ID: 1692416

Uniformat Code: D3042  
Recommendation: **Install in 2020**

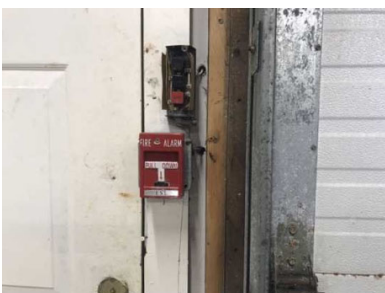
**Manual Pull Station in Poor condition.**

pull station past EUL and should be replaced for reliability - AssetCALC ID: 1689899

Uniformat Code: D5037  
Recommendation: **Replace in 2020**

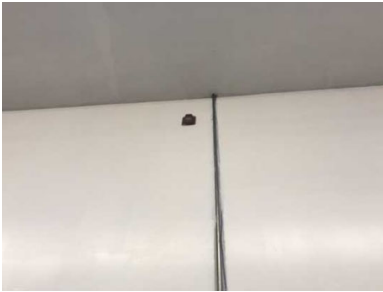
### Fire Alarm Horn and Strobe in Poor condition.

Fire alarm original to building and past EUL. should be replaced for reliability - AssetCALC ID: 1689911

Recommendation: **Replace in 2020**

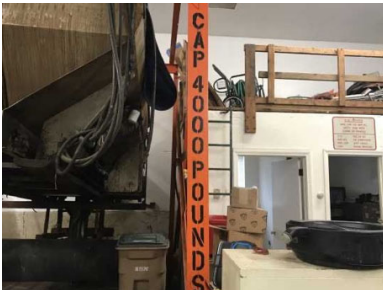
### Vehicle Lift in Poor condition.

Lifts are well past EUL. legs of vehicle lift are heavily rusting/ deteriorating - AssetCALC ID: 1689926

Recommendation: **Replace in 2020**

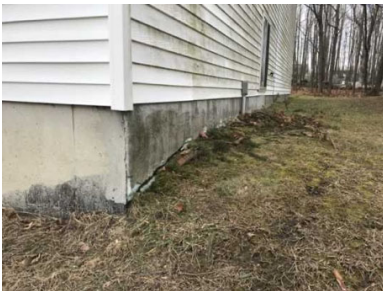
### Exterior Wall in Poor condition.

EIFS around foundation wall is deteriorating - AssetCALC ID: 1689890

Recommendation: **Replace in 2020**

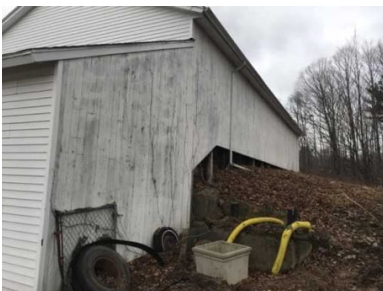
### Exterior Wall in Poor condition.

Exterior wall paint fading, should be replaced to prevent further deterioration of siding - AssetCALC ID: 1689906

Recommendation: **Prep and Paint in 2020**

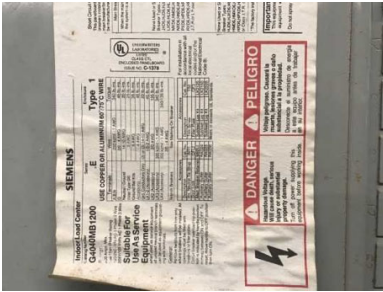
### Main Distribution Panel in Poor condition.

distribution panel experiencing accelerated deterioration/ rusting - AssetCALC ID: 1689916

Uniformat Code: D5012  
Recommendation: **Replace in 2021**

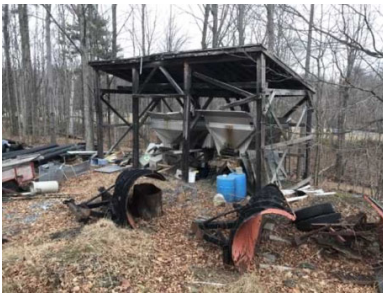
### Modular Building in Poor condition.

Modular building is falling apart and with wood rot throughout. Asset requires removal, with new modular lean-to building construction to be located on north wall of salt-storage shed - AssetCALC ID: 1689925

Uniformat Code: F1012  
Recommendation: **Replace in 2021**

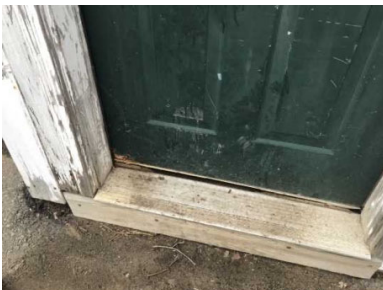
### Exterior Door in Poor condition.

Door is rusting and experiencing accelerated deterioration. Door sill is loose. Door hardware not ADA compliant - AssetCALC ID: 1689942

Uniformat Code: B2032  
Recommendation: **Replace in 2021**

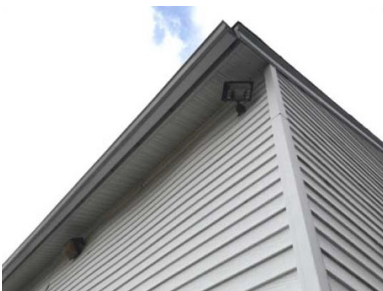
### Light Fixture in Poor condition.

remaining original exterior light fixture is near end of EUL - AssetCALC ID: 1689931

Uniformat Code: D5022  
Recommendation: **Replace in 2021**

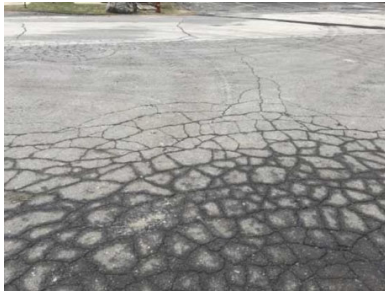
### Parking Lots in Poor condition.

Asphalt pavement sealant is faded - AssetCALC ID: 1689937

Uniformat Code: G2022  
Recommendation: **Seal and Stripe in 2021**

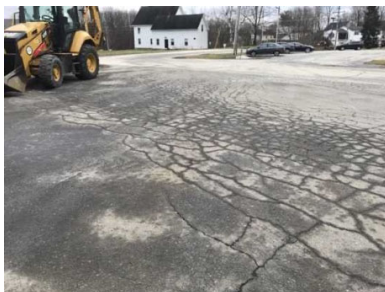
### Parking Lots in Poor condition.

The asphalt pavement has alligator cracking throughout which is reportedly in part the result of improper drainage from the garage downspouts. Water drainage should be redirected to prevent future cracking. A modular wood-framed structure located adjacent to the salt storage shed is heavily deteriorated and near failure. This should be replaced and relocated to the shed as a lean-to structure which will accommodate storage needs of the facility.

Asphalt pavement is spalling and alligator cracking throughout - AssetCALC ID: 1689929

Uniformat Code: G2022  
Recommendation: **Mill and Overlay in 2021**

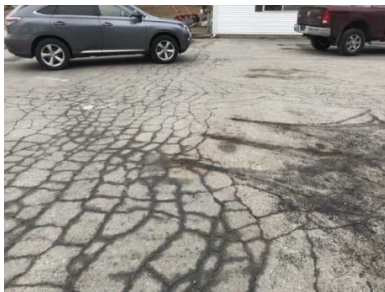
### Landscaping in Poor condition.

Drainage from southeast corner garage downspout is pooling and causing erosion under asphalt pavement, resulting in heavy cracking. Drainage must be redirected - AssetCALC ID: 1689934

Uniformat Code: G2052  
Recommendation: **Replace in 2021**

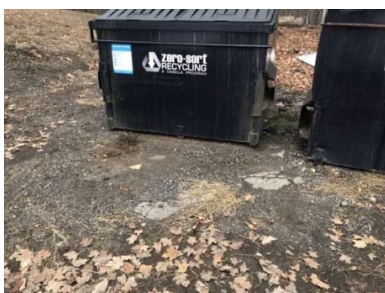
### Dumpster Accessories in Poor condition.

concrete pads for dumpsters are cracking/ spalled - AssetCALC ID: 1689896

Uniformat Code: G2049  
Recommendation: **Replace/Install in 2022**

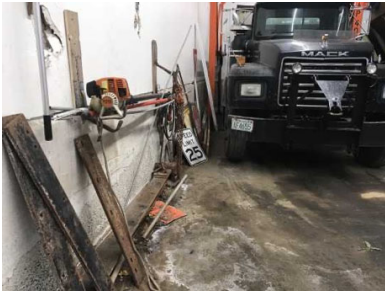
### Interior Wall Finish in Poor condition.

Water intrusion from west garage wall has caused spalling in concrete foundation - AssetCALC ID: 1689893

Uniformat Code: C3012  
Recommendation: **Repair in 2020**

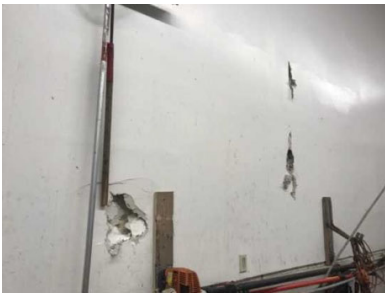
### Interior Wall Finish in Poor condition.

areas of gypsum board in garage damaged - AssetCALC ID: 1689898

Uniformat Code: C3012  
Recommendation: **Repair in 2020**

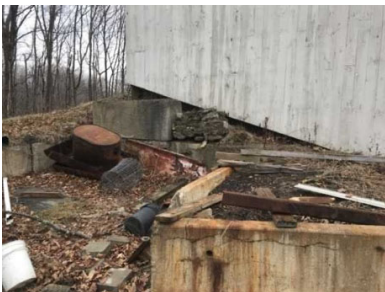
### Structure/Building in Poor condition.

foundation remains of old kennel to be removed from north side wall of salt-storage shed - AssetCALC ID: 1689922

Uniformat Code: F201X  
Recommendation: **Demolition and Disposal in 2020**

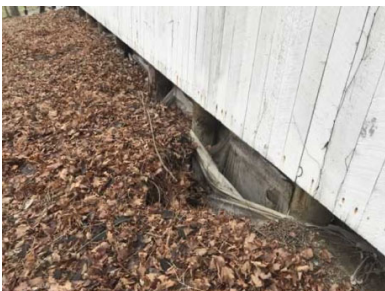
### Retaining Wall

A non-permeable cement wall should be installed around underground building exterior to prevent groundwater contamination of salt in accordance with state environmental regulations - AssetCALC ID: 1689900

Uniformat Code: G2042  
Recommendation: **Replace in 2020**

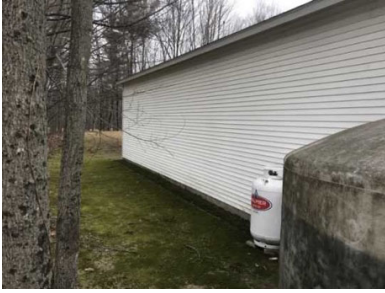
## Gutters and Downspouts in Poor condition.

lack of gutters causing water intrusion on west garage wall. Gutters/downspouts should be installed to redirect water flow - AssetCALC ID: 1689918

Uniformat Code: B3016  
Recommendation: **Replace in 2020**

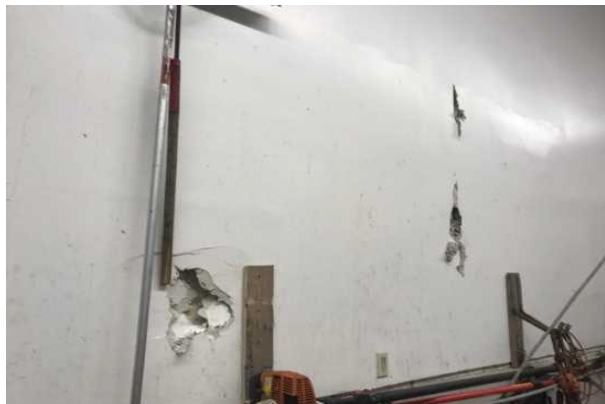
#34

DAMAGED GYPSUM BOARD,  
GARAGE
