FACILITY CONDITION ASSESSMENT

TOWN OF ATKINSON

TOWN HALL

19 Academy Avenue
Atkinson, New Hampshire 03811

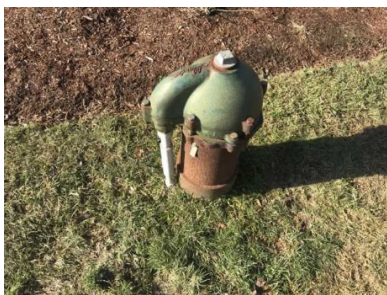
Well pressure system inadequate to serve fire-sprinkler system. Professional should be retained to determine necessary modifications, replacement of well components recommended. - AssetCALC ID: 1695914

**Recommended Follow-up Study:**

Town Hall Site

Uniformat Code: P000X
Recommendation: **Evaluate/Report in 2020**

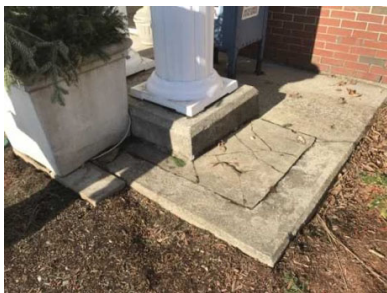
Well pressure system inadequate to serve fire-sprinkler system. Professional should be retained to determine necessary modifications, replacement of well components recommended. - AssetCALC ID: 1693874

**Structural Flooring/Decking in Poor condition.**

Concrete
Town Hall Building Entrance

Uniformat Code: B1012
Recommendation: **Replace in 2020**

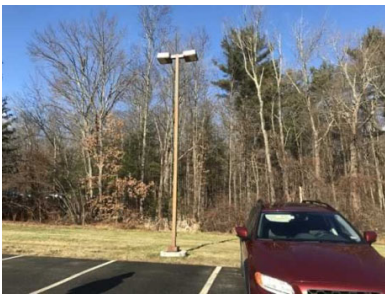
Water drainage from roof causing damage to cement pad at building entrance. Install gutters to redirect water and prevent future damage - AssetCALC ID: 1693977

Site Pole Light in Poor condition.

105 - 200 WATT
Town Hall Site

Uniformat Code: G4021
Recommendation: **Replace/Install in 2020**

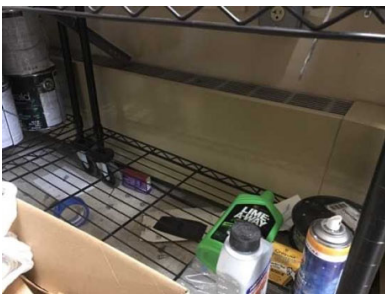
Site pole lighting is original to construction and rusted - AssetCALC ID: 1693865

Fan Coil Unit in Poor condition.

350 CFM
Town Hall Electrical room

Uniformat Code: D3041
Recommendation: **Replace in 2020**

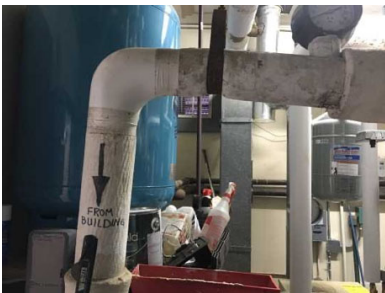
Fan coil unit is original to building construction and should be replaced for reliability - AssetCALC ID: 1693896

Pipe Insulation in Poor condition.

Fiberglass, Heating Water/Steam
Town Hall

Uniformat Code: D3024
Recommendation: **Replace in 2020**

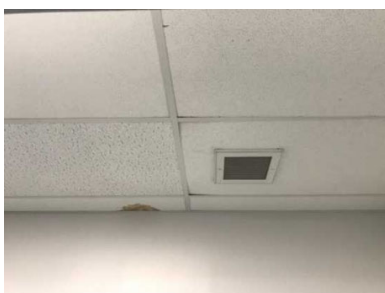
VCT is original to building. Finish is scratched, stained and peeling in areas - AssetCALC ID: 1693872

**Interior Ceiling Finish in Poor condition.**

Suspended Acoustical Tile (ACT)
Town Hall Restrooms

Uniformat Code: C3032
Recommendation: **Replace in 2020**
