# FACILITY CONDITION ASSESSMENT

## TOWN OF ATKINSON

## COMMUNITY CENTER

4 Main Street  
Atkinson, New Hampshire 03814

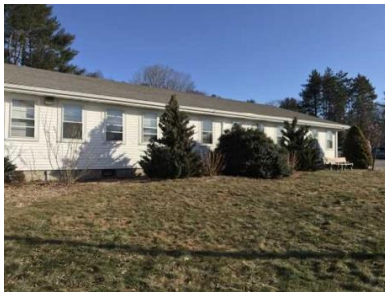
**Pedestrian Pavement in Poor condition.**

Sidewalk, Concrete Large Areas  
Community Center Site - South Side

it is reported that a concrete path from the parking lot to the south entrance of the building is needed for pedestrians - AssetCALC ID: 1711434

Uniformat Code: G2031  
Recommendation: **Replace in 2020**

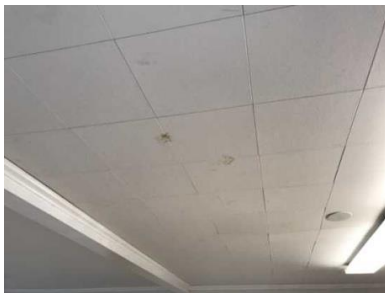
**Recommended Follow-up Study: Environmental, Asbestos (ACM) & Lead Base Paint (LBP)**

Environmental, Asbestos (ACM) & Lead Base Paint (LBP)  
Community Center Throughout building

Suspect lead paint and asbestos containing ceiling tiles in the East building - AssetCALC ID: 1711405

Uniformat Code: P000X  
Recommendation: **Evaluate/Report in 2020**

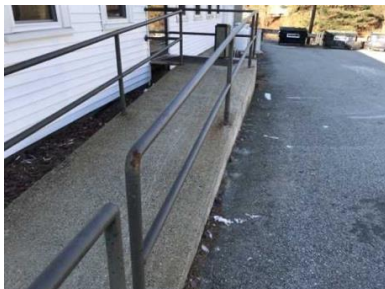
**Exterior Stair/Ramp Rails in Poor condition.**

Metal  
Community Center Site

railing is beginning to rust - AssetCALC ID: 1711355

Uniformat Code: B1015  
Recommendation: **Refinish in 2020**

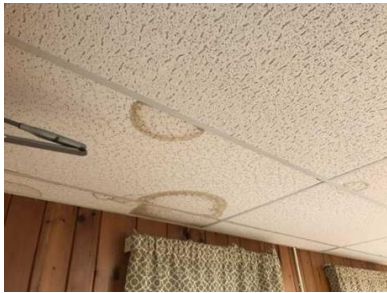
### Roof in Poor condition.

Asphalt Shingle 20-Year  
Community Center Roof above kitchen

ceiling in recreation room corner next to kitchen leaks - AssetCALC ID: 1711976

Uniformat Code: B3011  
Recommendation: **Repair in 2020**

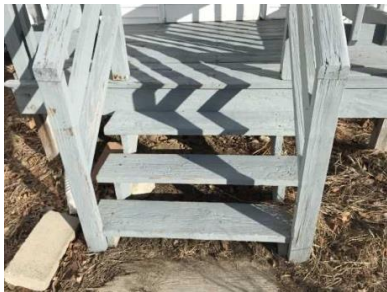
### Exterior Stairs in Poor condition.

Wood  
Community Center Site

exterior wooden stair finish is deteriorated - AssetCALC ID: 1711440

Uniformat Code: B1015  
Recommendation: **Refinish in 2020**

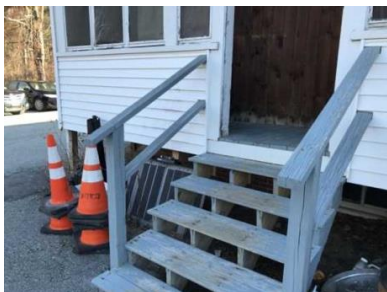
### Exterior Stair/Ramp Rails in Poor condition.

Wood  
Community Center Site

Railing finish is deteriorated, exposing wood underneath - AssetCALC ID: 1711368

Uniformat Code: B1015  
Recommendation: **Refinish in 2020**

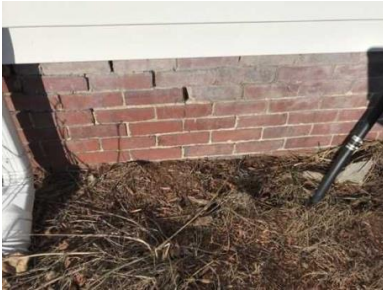
### Exterior Wall in Poor condition.

Brick or Brick Veneer, 1-2 Stories  
Community Center Building Exterior

Deteriorating and loose mortar joints at brick and CMU foundational wall - AssetCALC ID: 1711435

Uniformat Code: B2011  
Recommendation: **Repair/Repoint in 2020**

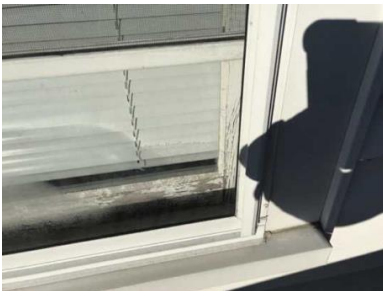
### Window in Poor condition.

12 SF  
Community Center East Building Exterior

7 wood framed window replacements planned for 2020 - AssetCALC ID: 1713273

Uniformat Code: B2021  
Recommendation: **Replace in 2020**

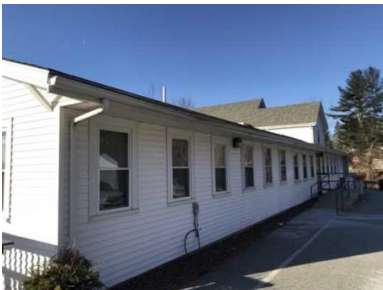
### Gutters & Downspouts in Poor condition.

Aluminum w/ Fittings  
Community Center Roof

gutter is damaged - AssetCALC ID: 1711431

Uniformat Code: B3016  
Recommendation: **Replace in 2020**

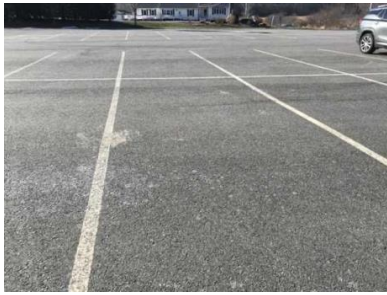
**Parking Lots in Poor condition.**

Asphalt Pavement  
Community Center New parking

Sealant is faded and parking stripes beginning to fade in asphalt lot - AssetCALC ID: 1711378

Uniformat Code: G2022  
Recommendation: **Seal & Stripe in 2021**

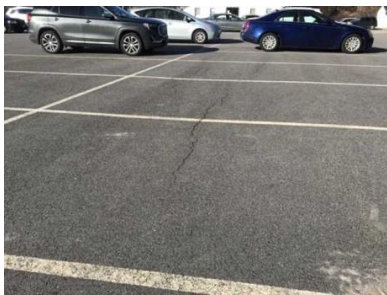
**Parking Lots in Poor condition.**

Asphalt Pavement  
Community Center New Parking

cracking in areas of newer asphalt lot - AssetCALC ID: 1711438

Uniformat Code: G2022  
Recommendation: **Cut & Patch in 2020**

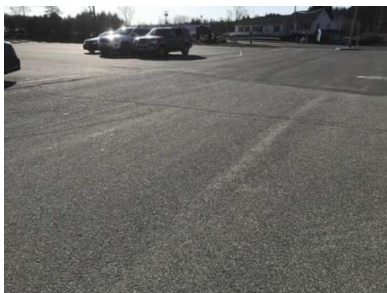
**Parking Lots in Poor condition.**

Asphalt Pavement  
Community Center Old lot

parking lot has severe alligator cracking - AssetCALC ID: 1711415

Uniformat Code: G2022  
Recommendation: **Mill & Overlay in 2021**

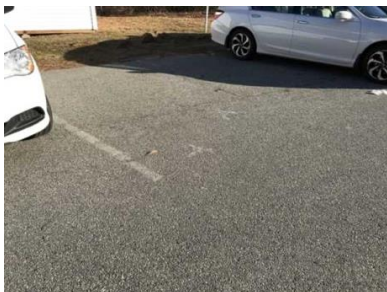
**Parking Lots in Poor condition.**

Asphalt Pavement  
Community Center Old lot

sealant and parking stripes are faded - AssetCALC ID: 1711375

Uniformat Code: G2022  
Recommendation: **Seal & Stripe in 2021**

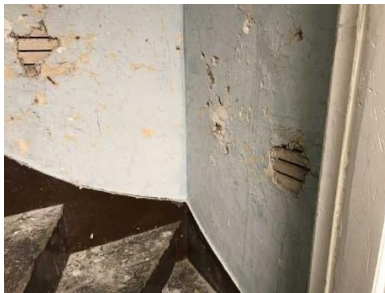
### Interior Wall Construction in Poor condition.

Gypsum Board/Plaster  
Community Center West House Attic

plaster in attic is in broken/ deteriorated condition - AssetCALC ID: 1711382

Uniformat Code: C1011  
Recommendation: **Replace in 2020**

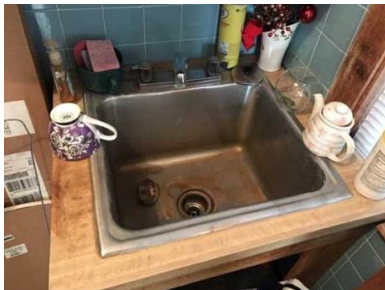
### Sink/Lavatory in Poor condition.

Vanity Top, Stainless Steel  
Community Center Utility closet

Sink is heavily rusting - AssetCALC ID: 1711409

Uniformat Code: D2014  
Recommendation: **Replace in 2020**

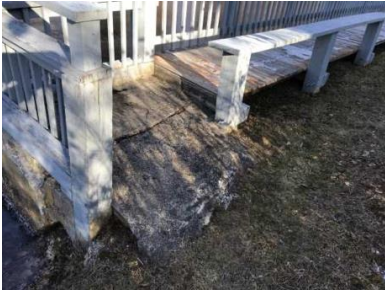
### Retaining Wall in Poor condition.

Cast-in-place Concrete (per SF Face)  
Community Center Site

concrete retaining wall at pond shows cracking and deterioration throughout and should be repaired - AssetCALC ID: 1711427

Uniformat Code: G2042  
Recommendation: **Repair in 2020**

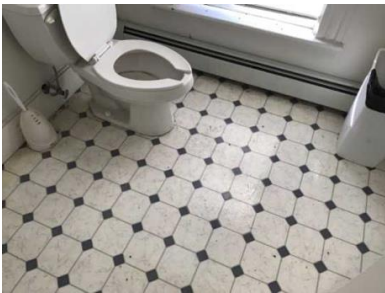
### Interior Floor Finish in Poor condition.

Vinyl Sheetting  
Community Center West House Restrooms

vinyl sheeting is worn and stained - AssetCALC ID: 1711410

Uniformat Code: C3024  
Recommendation: **Replace in 2021**

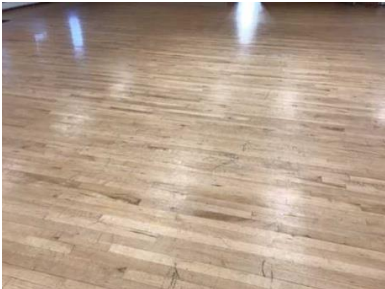
### Interior Floor Finish in Poor condition.

Maple Sports Floor  
Community Center Rec Room

floor finish is heavily scuffed and worn down - AssetCALC ID: 1711388

Uniformat Code: C3024  
Recommendation: **Refinish in 2021**

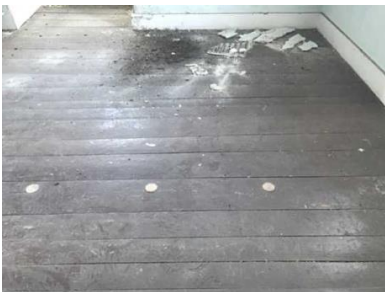
### Interior Floor Finish in Poor condition.

Wood Strip  
Community Center West House Attic

wood flooring finish is deteriorated - AssetCALC ID: 1711412

Uniformat Code: C3024  
Recommendation: **Refinish in 2020**

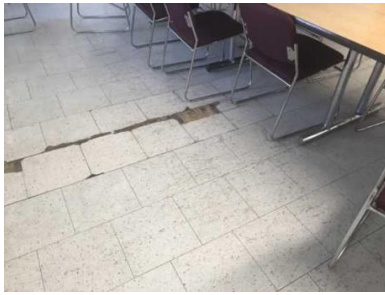
**Interior Floor Finish in Poor condition.**

Vinyl Tile (VCT)  
Community Center East Building Offices and Hall

VCT is aged, scuffed and breaking throughout - AssetCALC ID: 1711385

Uniformat Code: C3024  
Recommendation: **Replace in 2020**

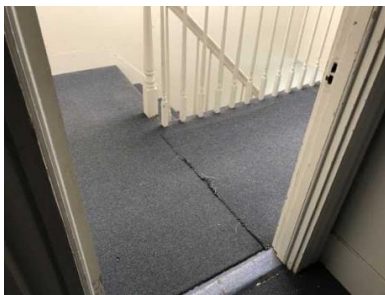
**Interior Floor Finish in Poor condition.**

Carpet Commercial Standard  
Community Center West House Throughout

carpet is aged and worn - AssetCALC ID: 1711432

Uniformat Code: C3025  
Recommendation: **Replace in 2022**

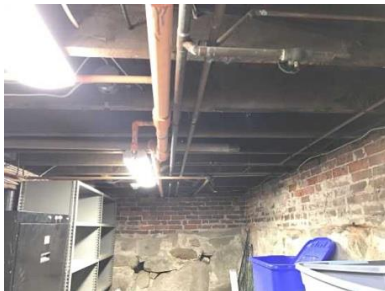
**Interior Wall Finish in Poor condition.**

Brick or Brick Veneer  
Community Center West House Basement

Areas of loose and deteriorating mortar joints in the west house basement brick/ masonry walls - AssetCALC ID: 1713327

Uniformat Code: C3012  
Recommendation: **Repair in 2020**

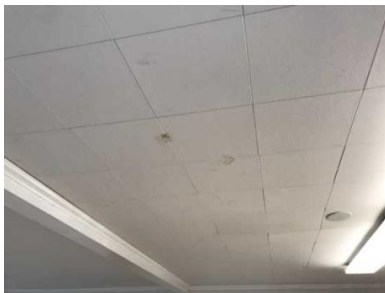
**Interior Ceiling Finish in Poor condition.**

Hard Tile Ceiling w/ ACT  
Community Center East Building Offices

tiles are aged, in deteriorating condition and are suspected to contain asbestos - AssetCALC ID: 1711356

Uniformat Code: C3032  
Recommendation: **Replace in 2021**

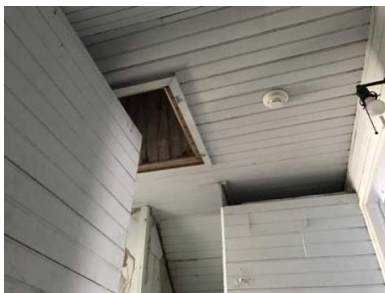
### Interior Ceiling Finish in Poor condition.

any flat surface  
Community Center West House Attic

ceiling in attic should be painted after new plaster/ drywall is installed - AssetCALC ID: 1711353

Uniformat Code: C3031  
Recommendation: **Prep & Paint in 2020**

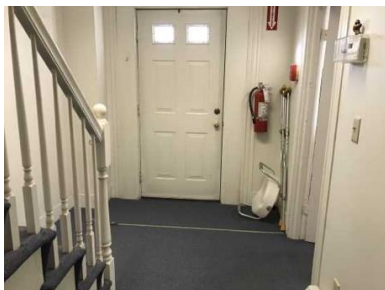
### Interior Wall Finish in Poor condition.

any surface  
Community Center Throughout building

painted wall finish is stained or chipped - AssetCALC ID: 1711400

Uniformat Code: C3012  
Recommendation: **Prep & Paint in 2020**

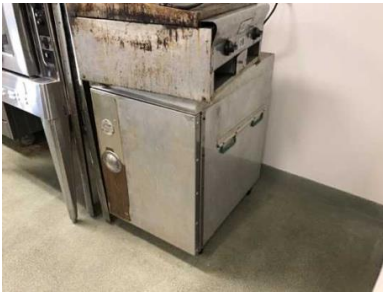
## Commercial Kitchen in Poor condition.

Food Warmer  
Community Center Kitchen

food warmer is aged and in deteriorating condition - AssetCALC ID: 1711387

Uniformat Code: E1093  
Recommendation: **Replace in 2020**

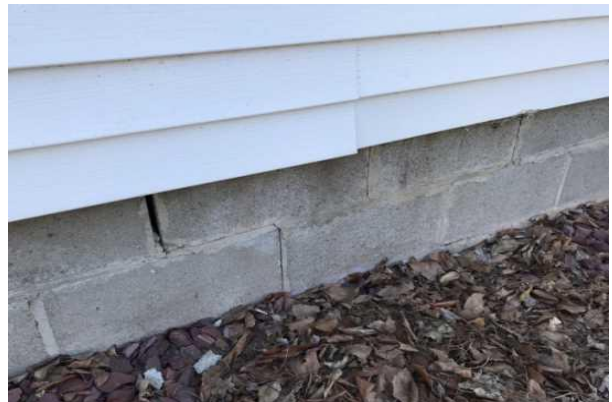
#18 CMU SUBSTRUCTURE, LOOSE MORTAR JOINTS
