# FACILITY CONDITION ASSESSMENT

**TOWN OF ATKINSON**  
21 Academy Avenue  
Atkinson, New Hampshire 03811  
David Cressman

**FAMILY MEDIATION**  
16 Academy Avenue  
Atkinson, New Hampshire 03816

February 3, 2020

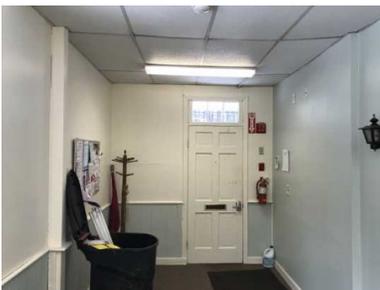
#### Emergency/Exit Combo LED

LED exit signs should be installed at building egress in case of emergency evacuation - AssetCALC ID: 1705661

Recommendation: **Replace in 2020**

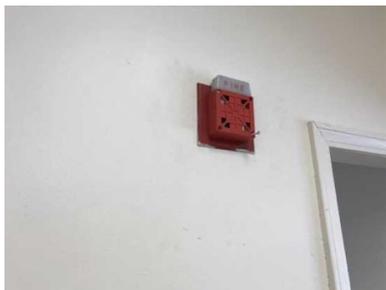
**Fire Alarm System in Poor condition.**

Fire alarm fixtures are dated and should be replaced for reliability - AssetCALC ID: 1704157

Uniformat Code: D5037  
Recommendation: **Upgrade/Install in 2020**

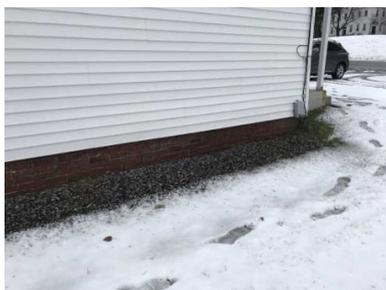
**Exterior Wall in Poor condition.**

Brick mortar joints at foundation are loose and deteriorating - AssetCALC ID: 1704158

Uniformat Code: B2011  
Recommendation: **Repair/Repoint in 2020**

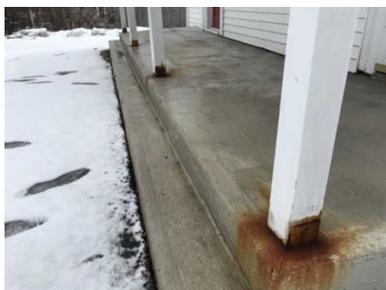
**Exterior Column in Poor condition.**

Ties rusted and causing deterioration to wood columns - AssetCALC ID: 1704146

Uniformat Code: B1013  
Recommendation: **Replace in 2020**

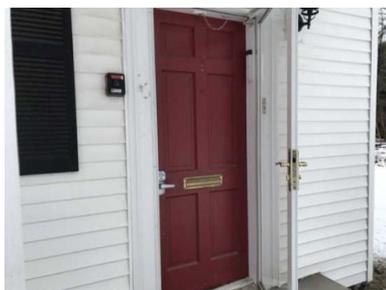
**Exterior Door in Poor condition.**

Door casing in deteriorated condition - AssetCALC ID: 1704154

Uniformat Code: B2032  
Recommendation: **Replace in 2020**

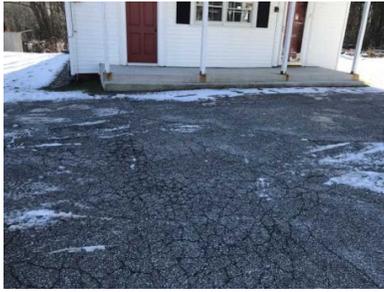
**Parking Lots in Poor condition.**

Parking lot is heavily alligator cracked throughout - AssetCALC ID: 1704170

Uniformat Code: G2022  
Recommendation: **Mill and Overlay in 2021**

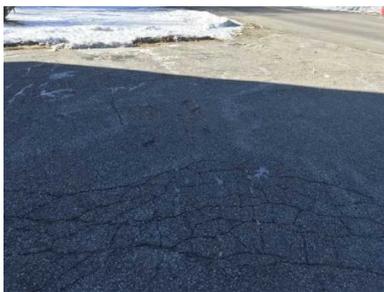
**Parking Lots in Poor condition.**

sealant on parking lot is faded - AssetCALC ID: 1704173

Uniformat Code: G2022  
Recommendation: **Seal and Stripe in 2021**

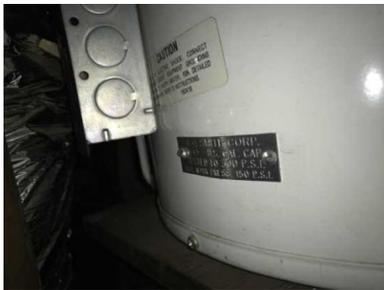
**Water Heater in Poor condition.**

water heater is aged, dented and deteriorating - AssetCALC ID: 1704144

Uniformat Code: D2023  
Recommendation: **Replace in 2021**

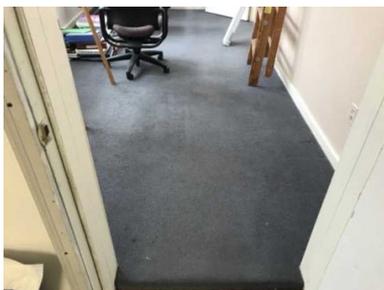
**Interior Floor Finish in Poor condition.**

carpet is aged, stained and loose - AssetCALC ID: 1704164

Uniformat Code: C3025  
Recommendation: **Replace in 2020**

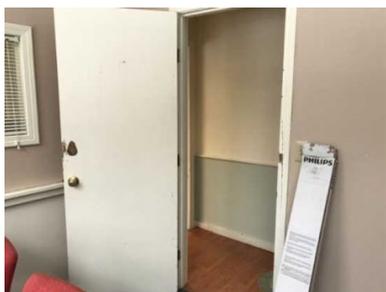
**Interior Door in Poor condition.**

Interior door is broken - AssetCALC ID: 1704155

Uniformat Code: C1021  
Recommendation: **Replace in 2020**

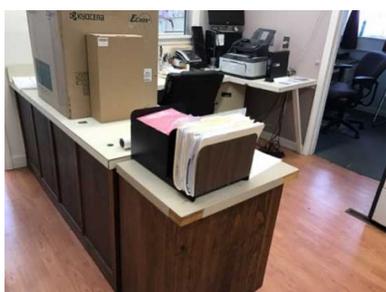
**Kitchen Cabinetry in Poor condition.**

cabinetry is aged and laminate is peeling - AssetCALC ID: 1704153

Uniformat Code: E2012  
Recommendation: **Replace in 2021**

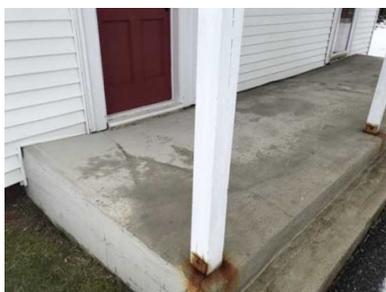
**Recommended Follow-up Study: Structural, Substructure**

Office area floor at the north end of the building dips significantly. House displacement visibly noticeable at the front porch concrete slab. An engineer should be retained to assess the structural integrity of the building - AssetCALC ID: 1704159

Uniformat Code: P000X  
Recommendation: **Evaluate/Report in 2020**

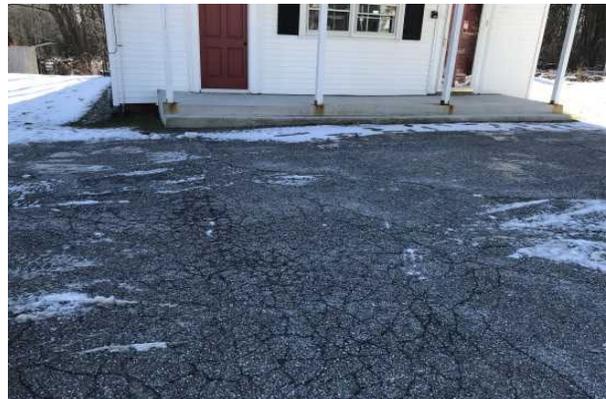
#6	PARKING LOTS, ASPHALT PAVEMENT, MILL AND OVERLAY
----	--

Asphalt pavement features heavy alligator cracking throughout and should be replaced. Cement deck at front porch is cracked, likely due to building settlement, and will require replacement before the end of its average useful life. No site lighting exists on the property.
