# FACILITY CONDITION ASSESSMENT

## TOWN OF ATKINSON

## FIRE STATION

1 ACADEMY AVENUE  
ATKINSON, NEW HAMPSHIRE 03812

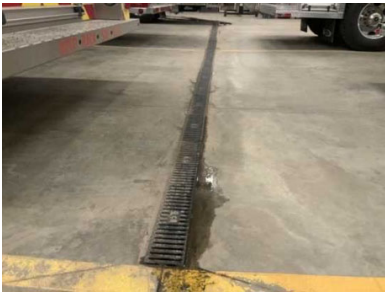
### Interior Floor Finish in Poor condition.

Concrete  
Fire Station Bay Area

Regrade - AssetCALC ID: 1705662

Uniformat Code: C3021  
Recommendation: **Repair in 2020**

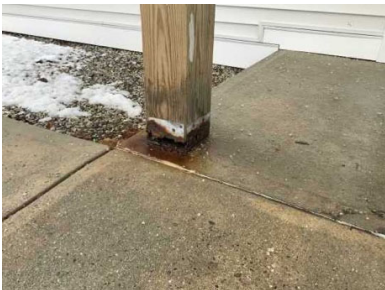
### Structural Frame in Poor condition.

Fire Station Building exterior

Deteriorating - AssetCALC ID: 1692488

Uniformat Code: B101X  
Recommendation: **in 2020**

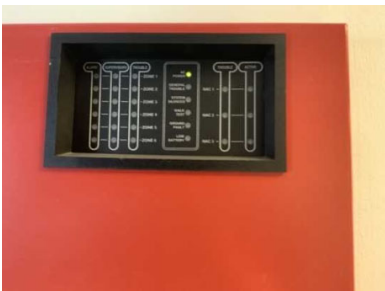
### Fire Alarm Control Panel

Addressable  
Fire Station 1<sup>st</sup> Floor

original to construction and should be replaced for reliability. - AssetCALC ID: 1701361

Uniformat Code: D5037  
Recommendation: **Replace in 2020**

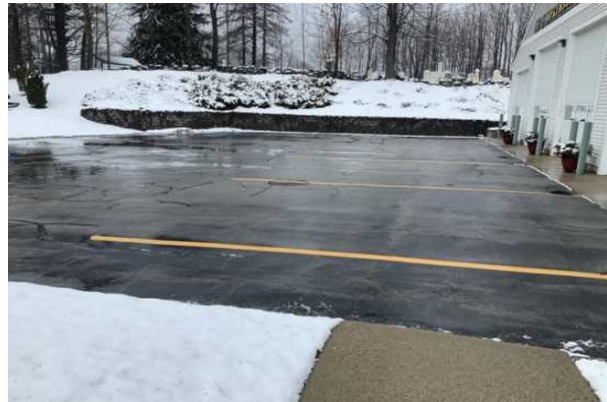
#10

There is a 7,000 SF asphalt parking lot with (25) total spaces. The asphalt parking lot has cracks and it will require repairs. The site has (18) parking lot bollards. The sidewalk is in good condition and was replaced in 2012. The landscaping is in good condition.

PARKING LOT

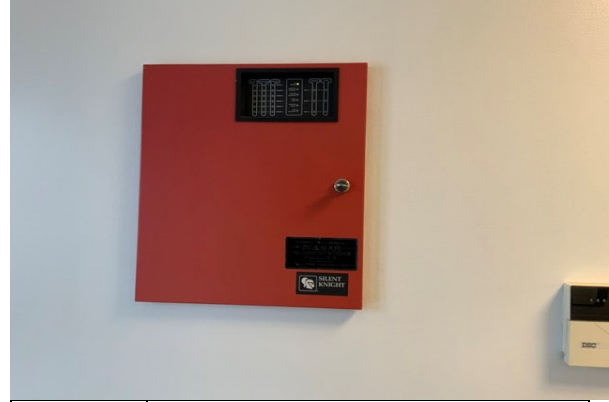
#26 FIRE ALARM CONTROL PANEL,  
ADDRESSABLE
