FACILITY CONDITION ASSESSMENT

TOWN OF ATKINSON

HISTORICAL SOCIETY

January 31, 2020

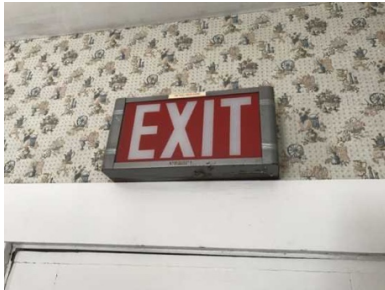
**Exit Sign Light Fixture in Poor condition.**

LED
Historical Society Throughout

Exit sign is antiquated and should be replaced with LED unit. Install where needed - AssetCALC ID: 1698834

Uniformat Code: D5092
Recommendation: **Replace and Install in 2020**

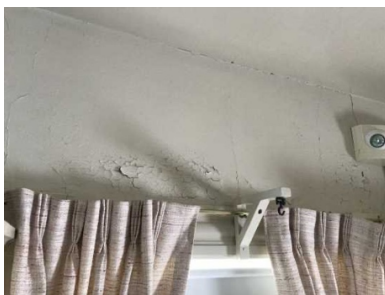
**Recommended Follow-up Study: Environmental, Sample for Lead Paint**

Old and cracking paint suggests the possible presence of Lead paint. Samples should be taken to determine the presence of lead - AssetCALC ID: 1698845

Uniformat Code: P000X
Recommendation: **Evaluate/Report in 2020**

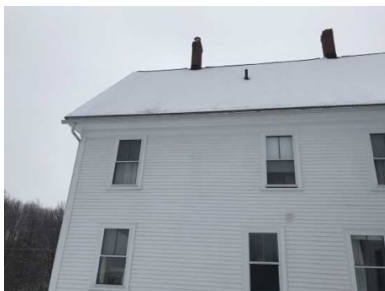
**Chimney in Poor condition.**

Brick or Brick Veneer, 1-2 Stories
Historical Society Roof

Middle and Garage brick masonry chimney's appear to be in deteriorating condition. Mortar casing to chimneys in attic is cracking and require repair - AssetCALC ID: 1698803

Uniformat Code: B2011
Recommendation: **Repair/Repoint in 2020**

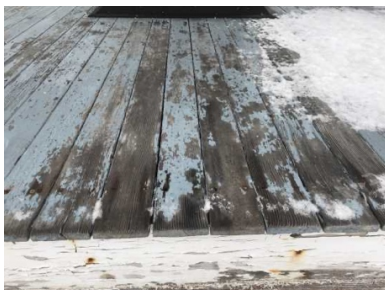
**Structural Flooring/Decking in Poor condition.**

Wood decking is loose and wood boards deteriorating - AssetCALC ID: 1698823

Uniformat Code: B1012
Recommendation: **Replace in 2020**

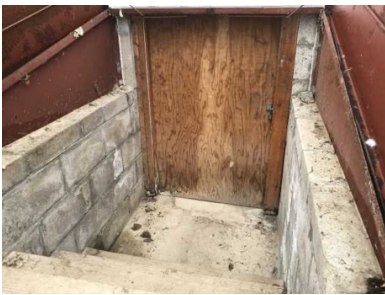
Exterior Wall in Poor condition.

Concrete Block (CMU), 1-2 Stories
Historical Society Bulkhead

Water intrusion to basement reportedly coming from bulkhead. CMU wall must be re-pointed to prevent further water intrusion - AssetCALC ID: 1698816

Uniformat Code: B2011
Recommendation: **Repair/Repoint in 2020**

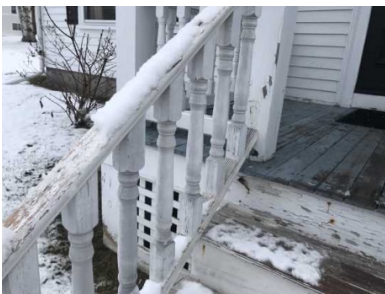
Exterior Stair/Ramp Rails in Poor condition.

Rail finish is faded and chipped. Needs to be refinished to protect wooden railing - AssetCALC ID: 1698787

Uniformat Code: B1015
Recommendation: **Refinish in 2020**

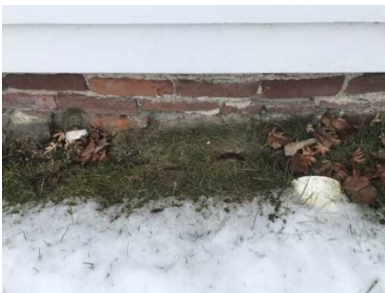
Exterior Wall in Poor condition.

brick masonry joints deteriorating, requiring repoint - AssetCALC ID: 1698799

Uniformat Code: B2011
Recommendation: **Repair/Repoint in 2020**

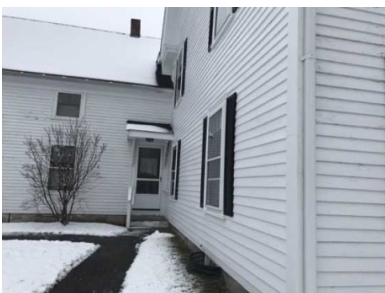
Exterior Wall in Poor condition.

Exterior wood clapboard siding paint is deteriorating and cracked - AssetCALC ID: 1698833

Uniformat Code: B2011
Recommendation: **Prep & Paint in 2021**

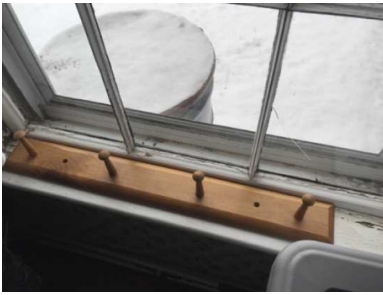
Window in Poor condition.

Cracked pane - AssetCALC ID: 1698789

Uniformat Code: B2021
Recommendation: **Replace in 2020**

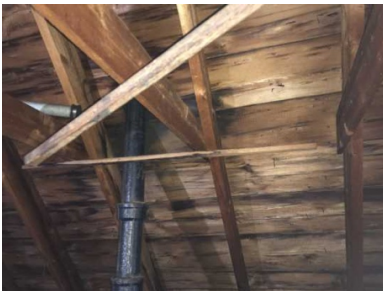
Pipe & Fittings in Poor condition.

Cast-iron ventilation piping is being poorly supported in the attic, should be replaced with PVC - AssetCALC ID: 1701416

Uniformat Code: D2021
Recommendation: **Replace in 2020**

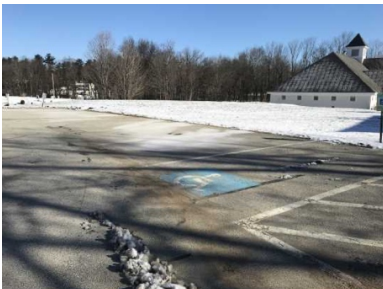
Parking Lots in Poor condition.

Sealant and parking stripes beginning to fade - AssetCALC ID: 1698794

Uniformat Code: G2022
Recommendation: **Seal & Stripe in 2022**

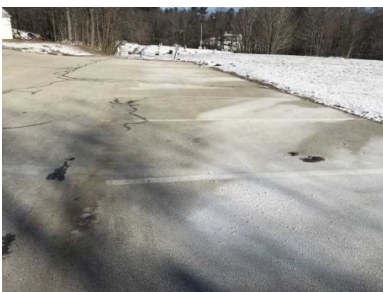
Parking Lots in Poor condition.

Asphalts pavement beginning to crack throughout - AssetCALC ID: 1698829

Uniformat Code: G2022
Recommendation: **Mill & Overlay in 2022**

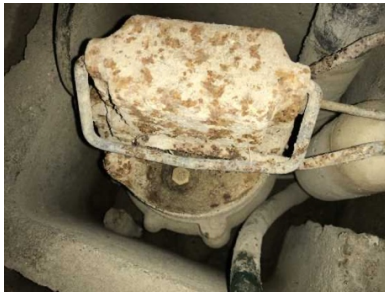
Sump Pump in Poor condition.

Sump pump is deteriorated and should be replaced to avoid flooding to basement - AssetCALC ID: 1698790

Uniformat Code: D2043
Recommendation: **Replace in 2020**

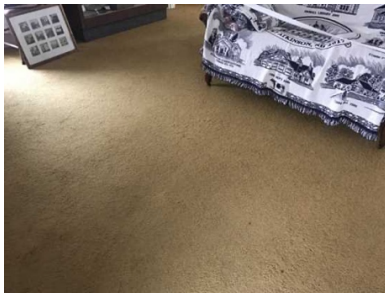
Interior Floor Finish in Poor condition.

Carpet is antiquated and worn. Should be replaced - AssetCALC ID: 1698830

Uniformat Code: C3025
Recommendation: **Replace in 2020**

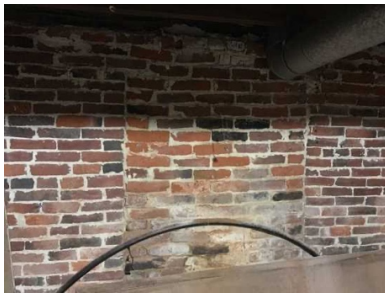
Interior Wall Finish in Poor condition.

Areas of brick wall in basement feature deteriorating brick and mortar joints. - AssetCALC ID: 1698817

Uniformat Code: C3012
Recommendation: **Repair/Repoint in 2020**

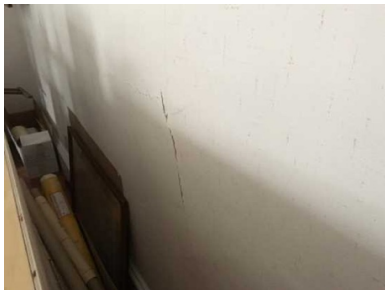
Interior Wall Finish in Poor condition.

Areas of plaster wall finish is cracking and require repair - AssetCALC ID: 1698824

Uniformat Code: C3012
Recommendation: **Repair in 2020**

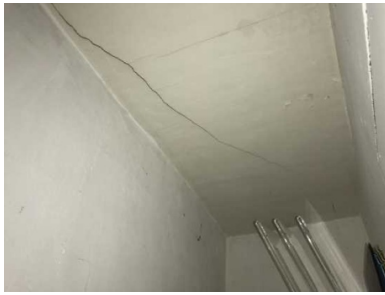
Interior Ceiling Finish in Poor condition.

Areas of plaster ceiling is cracked and requires repair - AssetCALC ID: 1698810

Uniformat Code: C3031
Recommendation: **Repair in 2020**

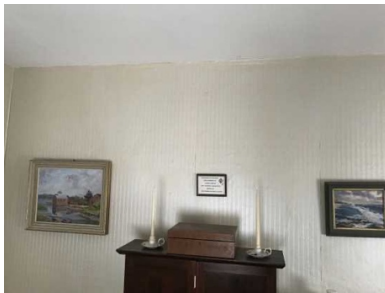
Interior Wall Finish in Poor condition.

Wallpaper finish is aged and peeling throughout - AssetCALC ID: 1698814

Uniformat Code: C3012
Recommendation: **Replace in 2020**

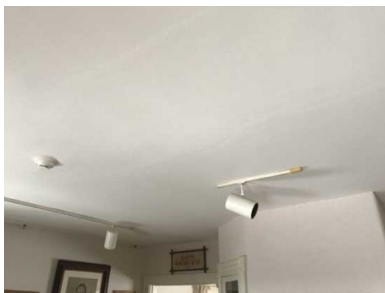
Interior Ceiling Finish in Poor condition.

Interior finish stained and fading. requires refinish after mortar is repaired - AssetCALC ID: 1698825

Uniformat Code: C3031
Recommendation: **Prep & Paint in 2021**

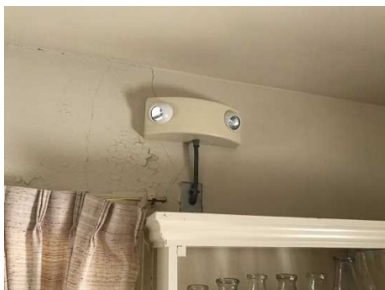
Interior Wall Finish in Poor condition.

Paint is peeling, cracked and stained. Should be refinished after repair of plaster - AssetCALC ID: 1698785

Uniformat Code: C3012
Recommendation: **Prep & Paint in 2020**

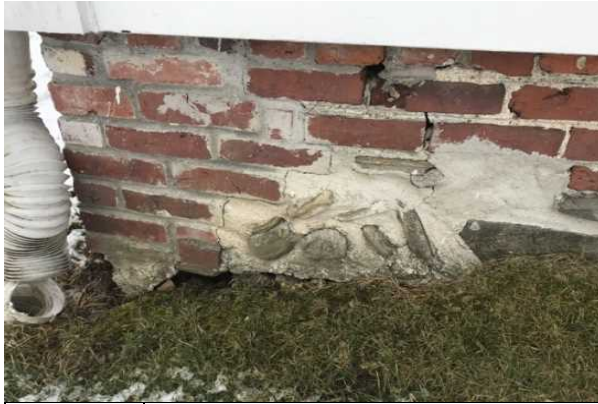
#13

EXTERIOR WALL, ZIPPER-LINE
CRACK

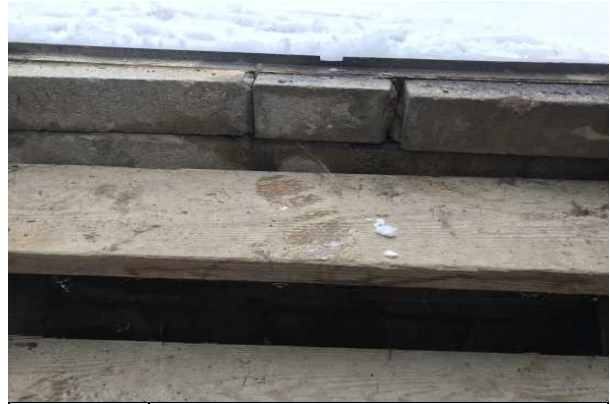
#14

BULKHEAD CMU WALL,
DETERIORATING MORTAR
JOINTS

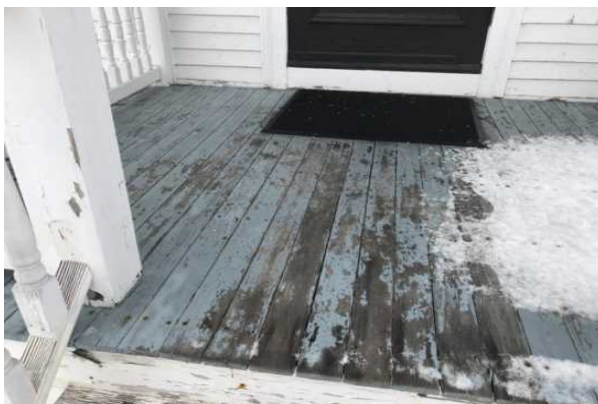
#15

PORCH DECKING, LOOSE WOOD

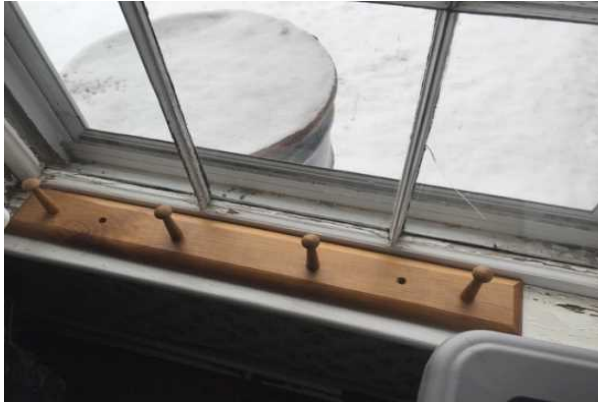
#19	WINDOW, WOOD, CRACKED
-----	-----------------------

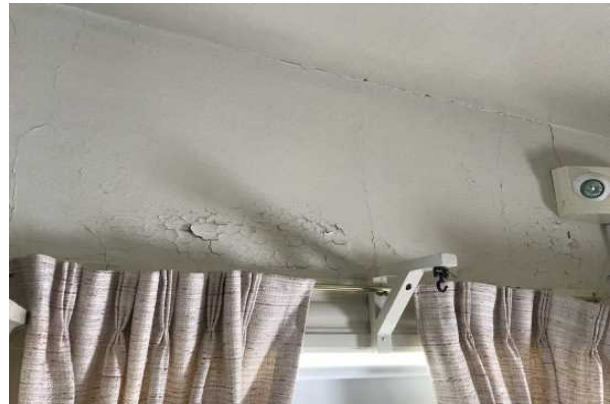
#38

SUSPECT LEAD PAINT

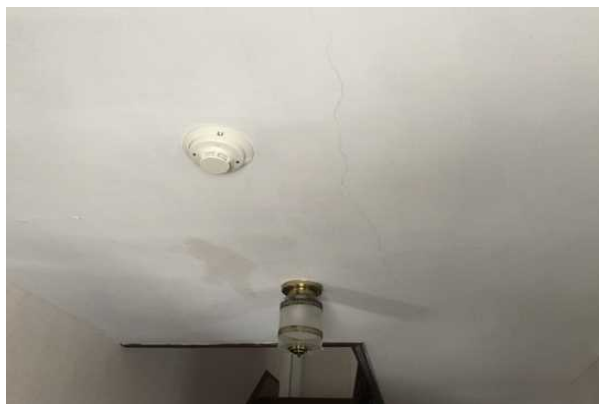
#39

INTERIOR CEILING FINISH,
PLASTER, CRACKED
