FACILITY CONDITION ASSESSMENT

LIBRARY

5 Academy Avenue
Atkinson, New Hampshire 03813

January 31, 2020

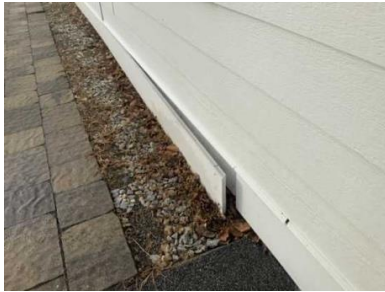
Exterior Wall in Poor condition.

Wood Clapboard Siding, 1-2 Stories
Library Building exterior

Deteriorating siding from water infiltration, roof does not have drainage system. - AssetCALC ID: 1700117

Uniformat Code: B2011
Recommendation: **Repair in 2020**

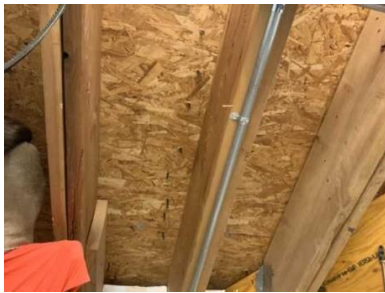
Roof Structure (Decking) in Poor condition.

any type per man-day
Library Attic

Anchors not attached to truss in attic - AssetCALC ID: 1700171

Uniformat Code: B3011
Recommendation: **Reroof in 2020**

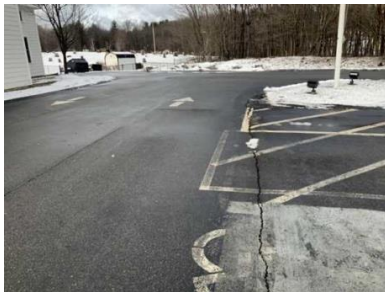
Parking Lots in Poor condition.

Library Site

Cracked Asphalt - seal and stripe. - AssetCALC ID: 1700767

Uniformat Code: G2022
Recommendation: **Cut and Patch in 2020**

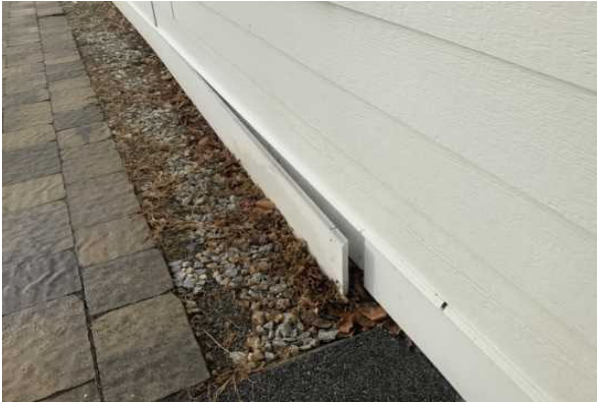
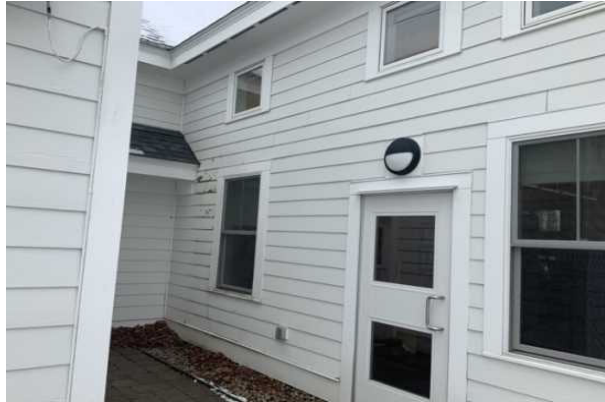
Loose siding, roof sheathing not correctly nailed to trusses in attic, cracked asphalt pavement. The CertainTeed make siding installed on the library does not seem to have been installed in accordance with the instructions from the manufacturer. This has been unearthed by a third party and dated 12/11/19.

1. The BVNA assessor has confirmed that the siding installation was not performed as per the manual especially the butt end flashing.
2. The bowing of the siding doesn't conform with the manufacture spec of 1/2" from the plane. This with the fact that the flashing is missing at the butt joint is leading the cement boards to absorb moisture and causing them to crack.

3. Further issues pointed out here are related to the Kickout flashing, without which the snow tends to pile down causing the paint to get damaged and exposing the siding to external weather.

4. The siding used is 7" in place of the recommended 4" siding.
5. The siding was attached to the plywood incorrectly thus leaving insufficient space to install the flashing. This has resulted in the water infiltration through the nail holes into the exterior envelope.

6. The water infiltration from the nail holes can potentially damage the plywood inside causing further issues with the building structure due to excessive rotting of wood.

SIDING-ISSUE

7. BVNA recommends removing the siding and replacing it with vinyl siding throughout the exterior facia.

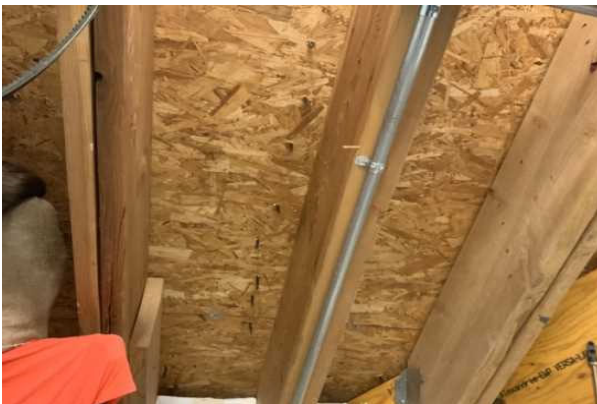
#9

The structure is in poor condition due to incorrect installation. The roof truss is not attached to supporting nails and exterior siding needs fastening. A professional structural engineer must be retained to analyze the existing condition, provide recommendations and, if necessary, estimate the scope and cost of any required repairs. The cost of this study is included in the cost tables.

ROOF/TRUSS- ISSUE
