# FACILITY CONDITION ASSESSMENT

## TOWN OF ATKINSON

## TOWN GARAGE

January 30, 2020

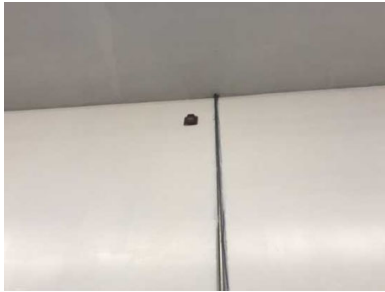
### Fire Alarm Horn and Strobe in Poor condition.

Fire alarm original to building and past EUL. should be replaced for reliability - AssetCALC ID: 1689911

Recommendation: **Replace in 2020**

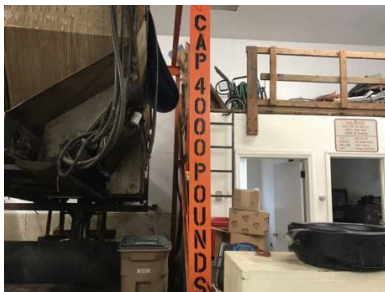
### Vehicle Lift in Poor condition.

Lifts are well past EUL. legs of vehicle lift are heavily rusting/ deteriorating - AssetCALC ID: 1689926

Recommendation: **Replace in 2020**

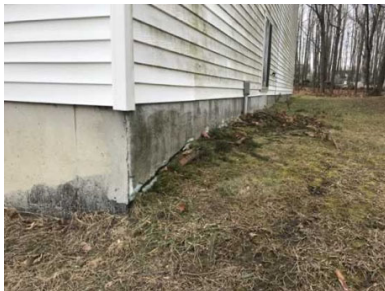
### Exterior Wall in Poor condition.

EIFS around foundation wall is deteriorating - AssetCALC ID: 1689890

Recommendation: **Replace in 2020**

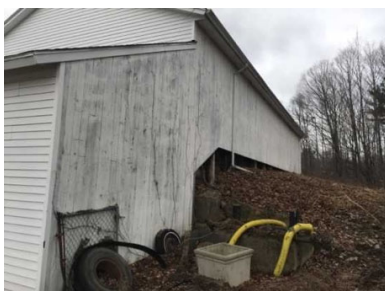
### Exterior Wall in Poor condition.

Exterior wall paint fading, should be replaced to prevent further deterioration of siding - AssetCALC ID: 1689906

Recommendation: **Prep and Paint in 2020**

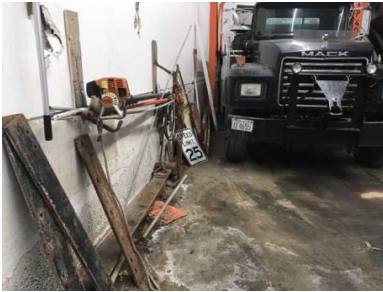
### Interior Wall Finish in Poor condition.

Water intrusion from west garage wall has caused spalling in concrete foundation - AssetCALC ID: 1689893

Uniformat Code: C3012  
Recommendation: **Repair in 2020**

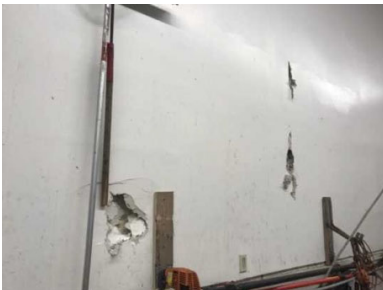
### Interior Wall Finish in Poor condition.

areas of gypsum board in garage damaged - AssetCALC ID: 1689898

Uniformat Code: C3012  
Recommendation: **Repair in 2020**

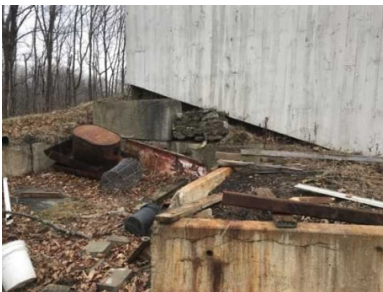
### Structure/Building in Poor condition.

foundation remains of old kennel to be removed from north side wall of salt-storage shed - AssetCALC ID: 1689922

Uniformat Code: F201X  
Recommendation: **Demolition and Disposal in 2020**

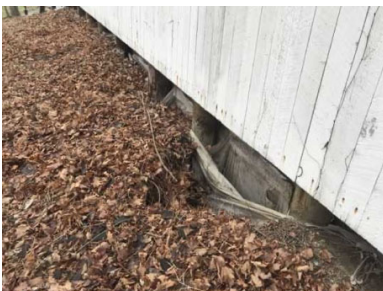
### Retaining Wall

A non-permeable cement wall should be installed around underground building exterior to prevent groundwater contamination of salt in accordance with state environmental regulations - AssetCALC ID: 1689900

Uniformat Code: G2042  
Recommendation: **Replace in 2020**

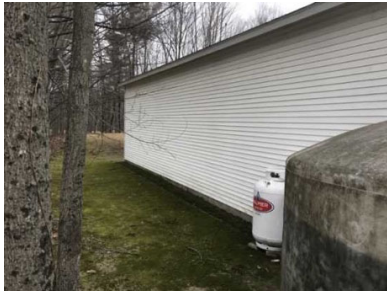
## Gutters and Downspouts in Poor condition.

lack of gutters causing water intrusion on west garage wall. Gutters/downspouts should be installed to redirect water flow - AssetCALC ID: 1689918

Uniformat Code: B3016  
Recommendation: **Replace in 2020**
