# FACILITY CONDITION ASSESSMENT

## TOWN OF ATKINSON

## TOWN HALL

February 3, 2020

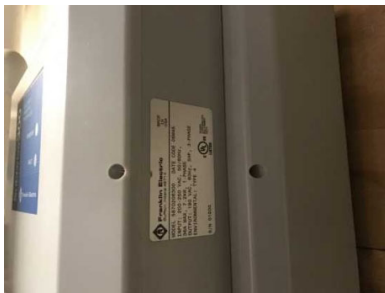
POC expressed need for emergency power during harsh winter months. Site currently does not have generator, one should be installed to prevent power outage to building - AssetCALC ID: 1694264

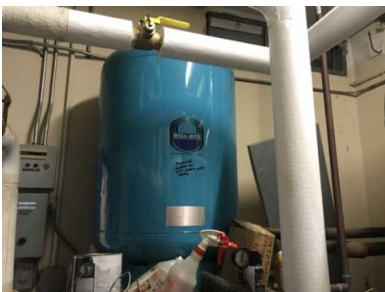
### Expansion Tank in Poor condition.

22 GAL  
Town Hall Mechanical room

Well pressure system inadequate to serve fire-sprinkler system. Professional should be retained to determine necessary modifications, replacement of well components recommended. - AssetCALC ID: 1693836

Uniformat Code: D3022  
Recommendation: **Replace in 2020**

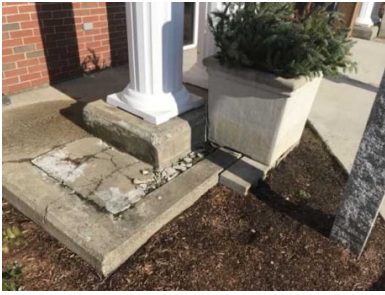
### Structural Flooring/Decking in Poor condition.

Concrete  
Town Hall Building Entrance

Cement pad below overhang pillars is severely cracked. Should be replaced to prevent damage to columns and overhang - AssetCALC ID: 1693845

Uniformat Code: B1012  
Recommendation: **Replace in 2020**
