# FACILITY CONDITION ASSESSMENT

**TOWN OF ATKINSON**  
21 Academy Avenue  
Atkinson, New Hampshire 03811  
David Cressman

**FAMILY MEDIATION**  
16 Academy Avenue  
Atkinson, New Hampshire 03816

February 3, 2020

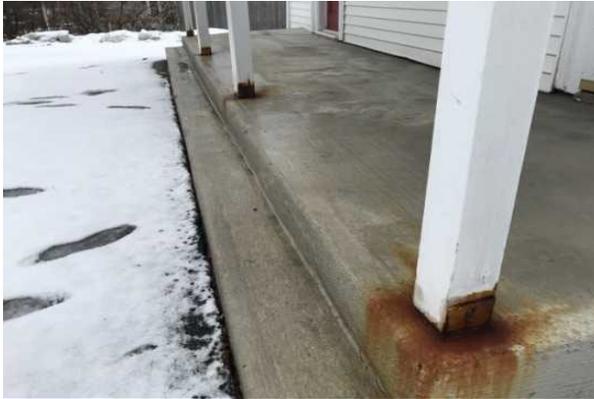
#7	FRONT PORCH
----	-------------

Areas of mortar joints to the brick foundational wall are deteriorating and require repoint. Column ties at the front porch are severely rusted and should be replaced to prevent collapse of the porch roof. Interior finishes are in generally fair condition, with the exception of worn carpet that should be replaced in office spaces.

Asphalt pavement features heavy alligator cracking throughout and should be replaced. Cement deck at front porch is cracked, likely due to building settlement, and will require replacement before the end of its average useful life. No site lighting exists on the property.

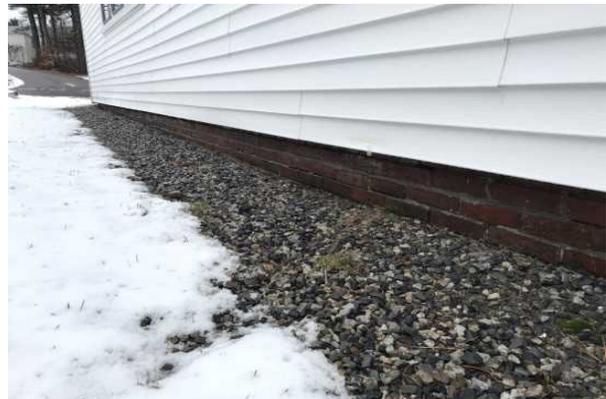
#12	BRICK SUBSTRUCTURE
-----	--------------------

Brick mortar joints at foundation are loose and deteriorating - AssetCALC ID: 1704158

Uniformat Code: B2011  
Recommendation: **Repair/Repoint in 2020**

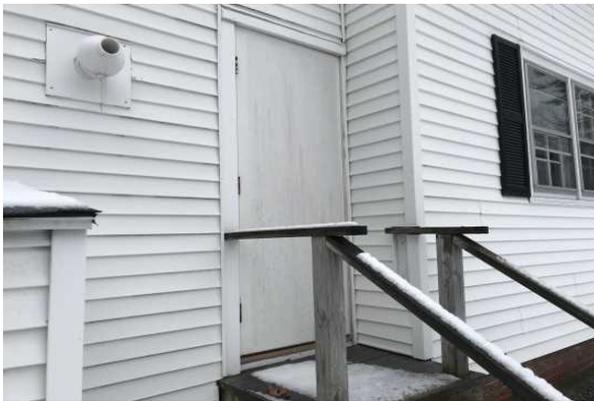
#17	EXTERIOR SIDE DOOR, WOOD SOLID-CORE
-----	-------------------------------------

Door casing in deteriorated condition - AssetCALC ID: 1704154

Uniformat Code: B2032  
Recommendation: **Replace in 2020**

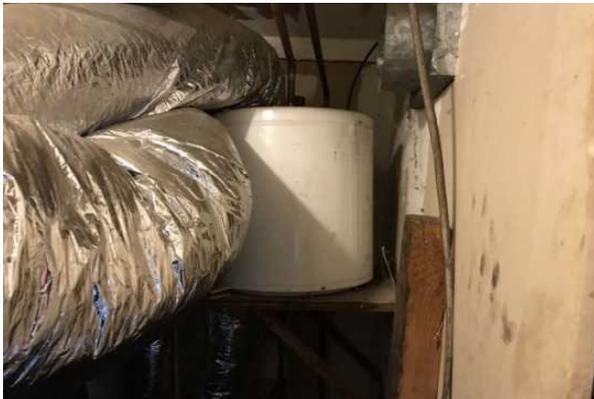
#21	WATER HEATER, ELECTRIC
-----	------------------------

A single 6-gallon electric water heater, which serves the restroom sink, is aged and should be replaced. Plumbing is comprised of copper and PVC with no apparent or reported issues.

water heater is aged, dented and deteriorating - AssetCALC ID: 1704144

Uniformat Code: D2023  
Recommendation: **Replace in 2021**

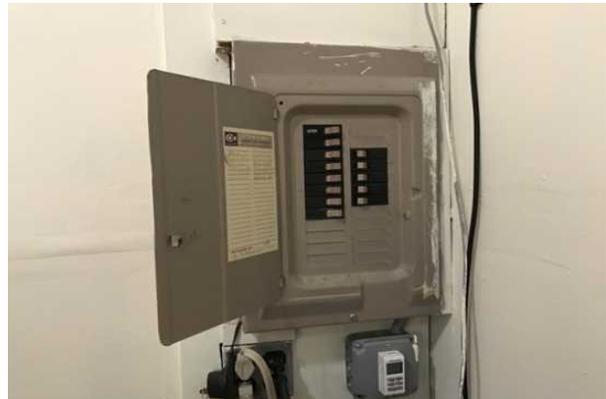
#22	MAIN DISTRIBUTION PANEL
-----	-------------------------

Building lighting fixtures appear adequately maintained/ replaced and consist of T8 and CFL lamps. The 100 Amp main distribution panel is dated and should be replaced in the near future.

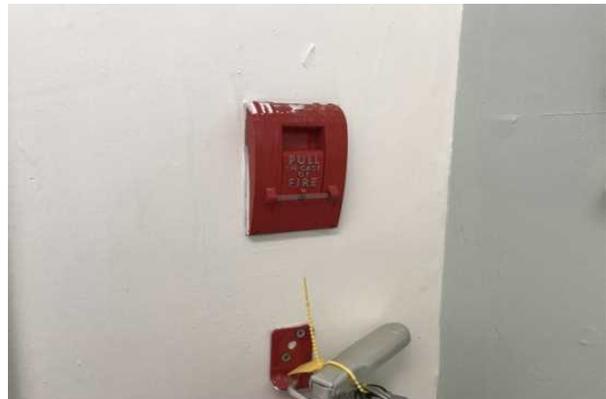
#24	FIRE ALARM SYSTEM, PULL STATION
-----	---------------------------------

Fire alarm system fixtures are also dated and should be replaced for reliability. LED emergency exit signs should be installed at building egress in case of emergency evacuation.

Fire alarm fixtures are dated and should be replaced for reliability - AssetCALC ID: 1704157

Uniformat Code: D5037  
Recommendation: **Upgrade/Install in 2020**
