# FACILITY CONDITION ASSESSMENT

## TOWN OF ATKINSON

## COMMUNITY CENTER

February 5, 2020

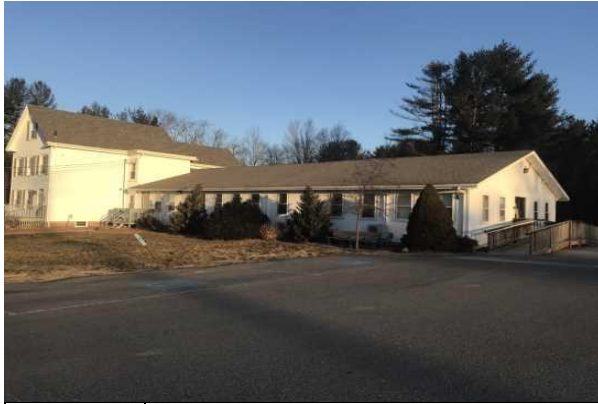
#1

OVERVIEW

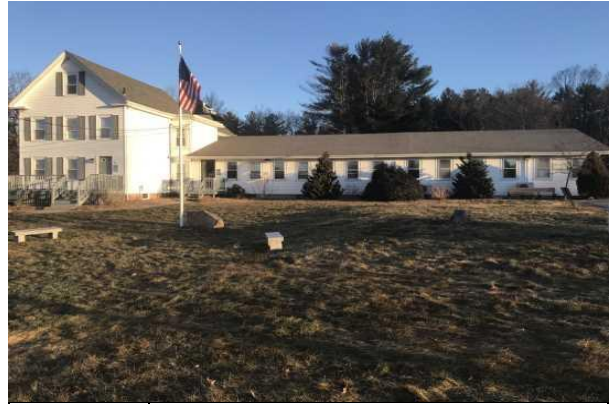
#2

FRONT ELEVATION

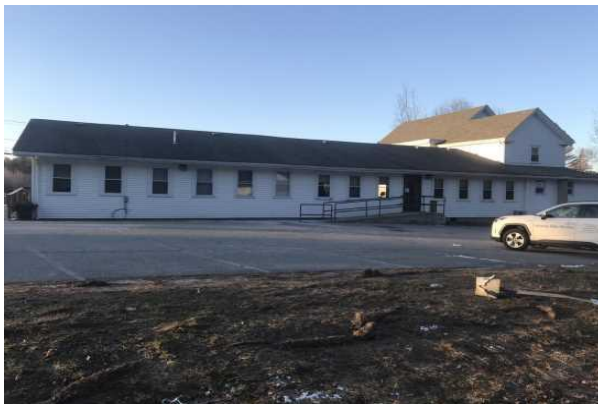
#3

REAR ELEVATION

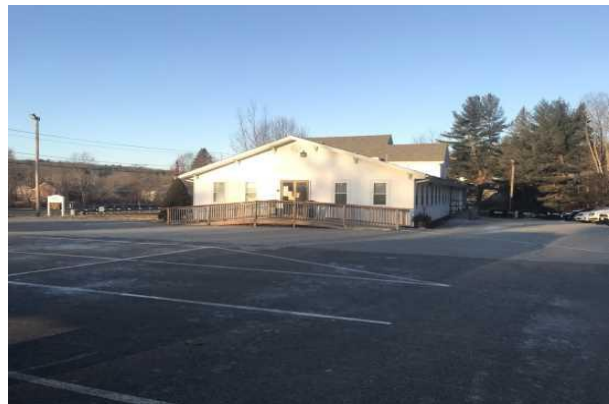
#4

RIGHT ELEVATION

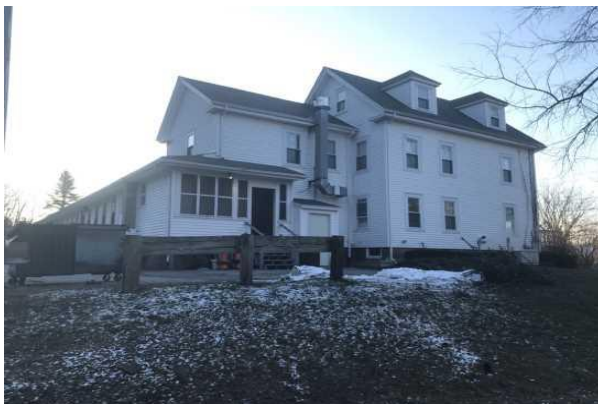
#5

LEFT ELEVATION

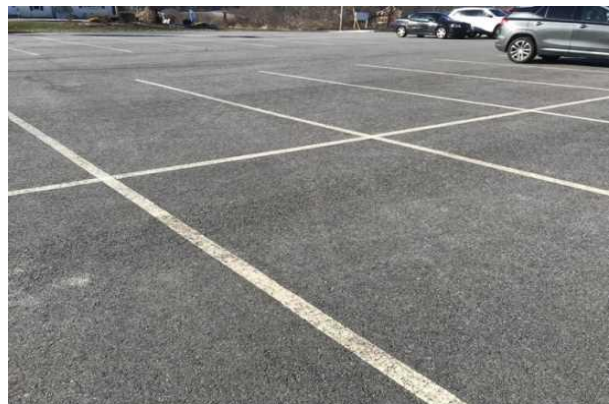
#6

EAST PARKING LOT

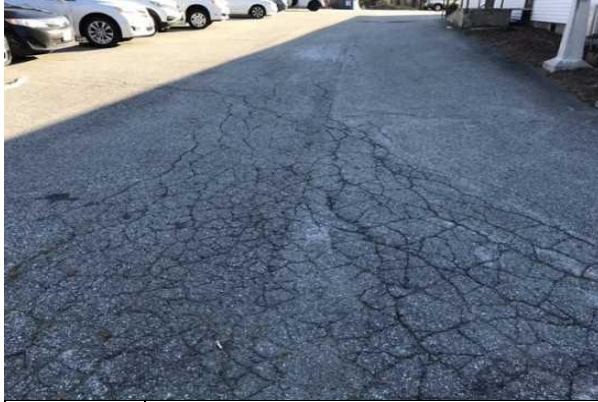
#7

The original parking lot on the north side of the building has alligator cracking throughout and requires mill/ overlay. Painted finishes to wooden ramps, decks, stairs and rails throughout the site are in poor condition and should be repainted to protect construction. The cement retaining wall at the pond on-site has cracks throughout and should be repaired to prevent structural failure. Lack of a walkway from the parking lot to the south entrance of the building is reportedly an obstacle for elderly pedestrians who routinely use this entrance. A cement sidewalk should be installed for better access.

NORTH PARKING LOT

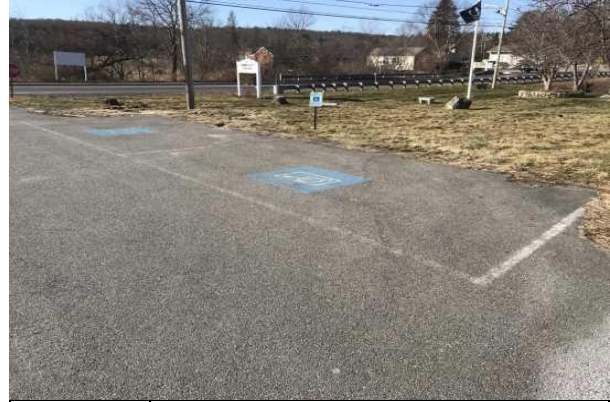
#8

ADA PARKING STALLS

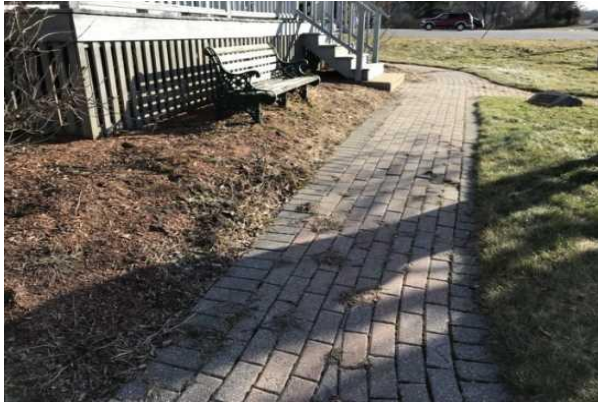
#9

PEDESTRIAN SIDEWALK, BRICK  
PAVERS

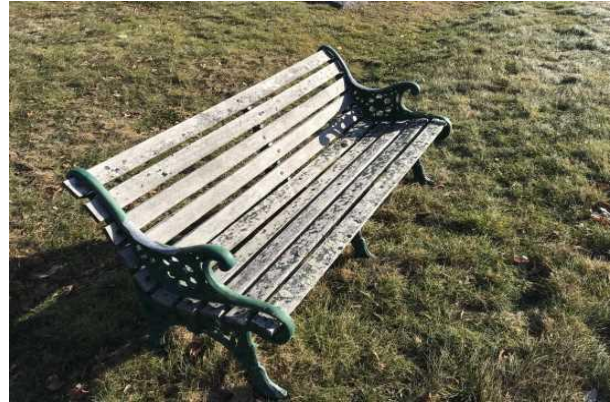
#10

SITE FURNISHINGS, PARK  
BENCH

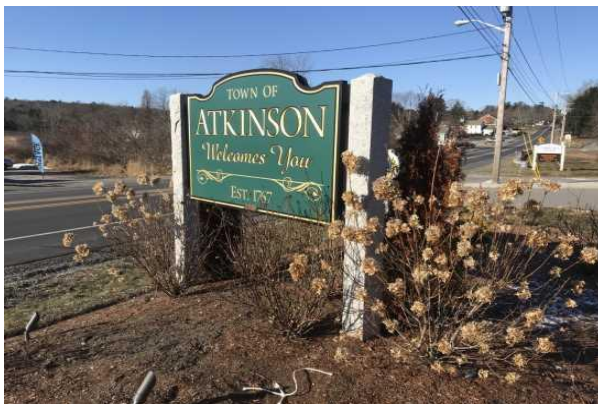
#11

PROPERTY SIGNAGE

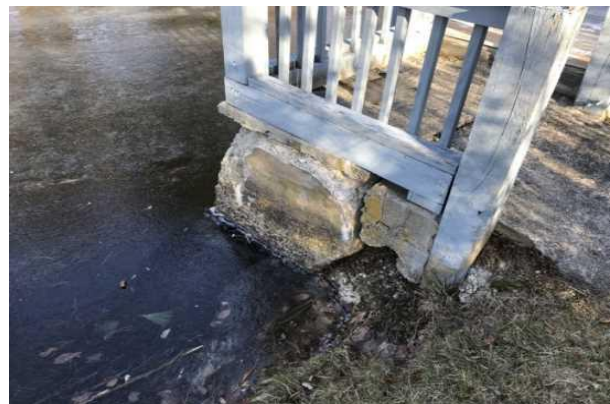
#12

RETAINING WALL, CAST-IN-  
PLACE CONCRETE

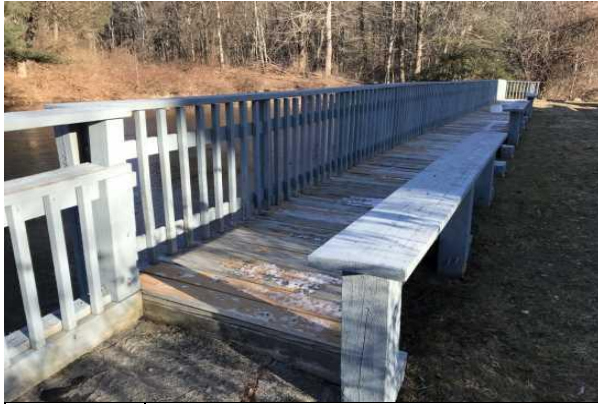
#13 POND BOARDWALK AND RAIL

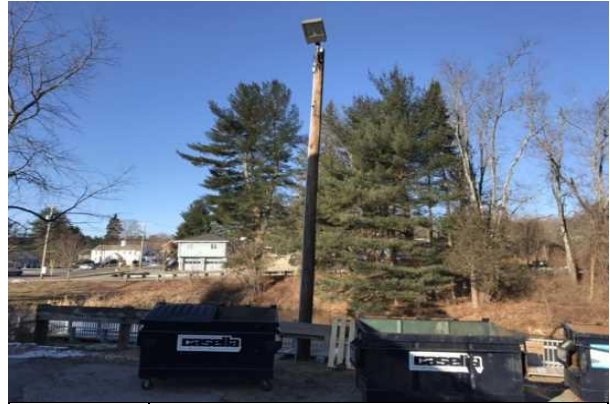
#14 SITE POLE LIGHT

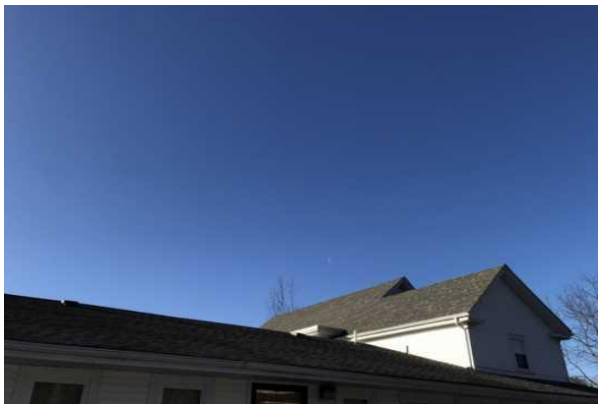
#15 ROOF, ASPHALT SHINGLE

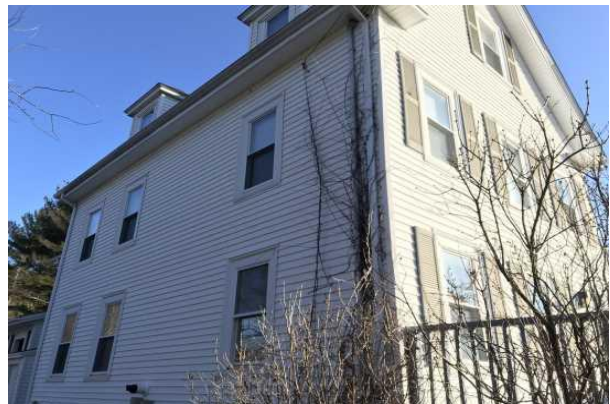
#16 EXTERIOR WALL, VINYL SIDING

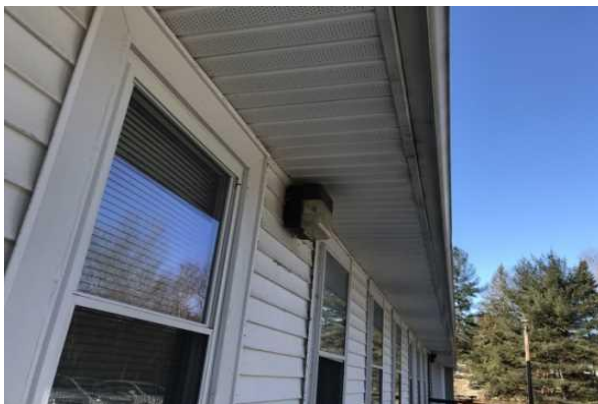
#17 EXTERIOR FLOOD LIGHTING

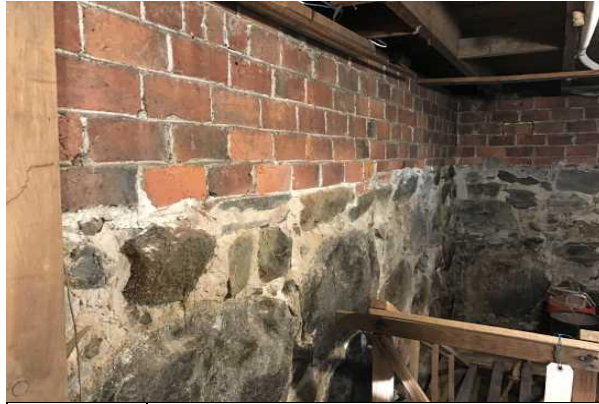
#19

Areas of loose and deteriorating mortar joints in the west portion basement brick/stone masonry walls and along the exterior substructure of the building require repoint. The third floor of the building has deteriorated and missing plaster walls/ ceilings throughout and should be replaced. There is suspect lead paint, which is heavily deteriorating, on the plaster of the third floor as well as suspect asbestos containing ceiling tiles in the eastern portion office spaces. Samples should be taken and tested for the presence of harmful materials before removal. Carpet and VCT flooring finishes are aged, in worn condition and should be replaced.

BASEMENT BRICK AND STONE  
MASONRY FOUNDATION

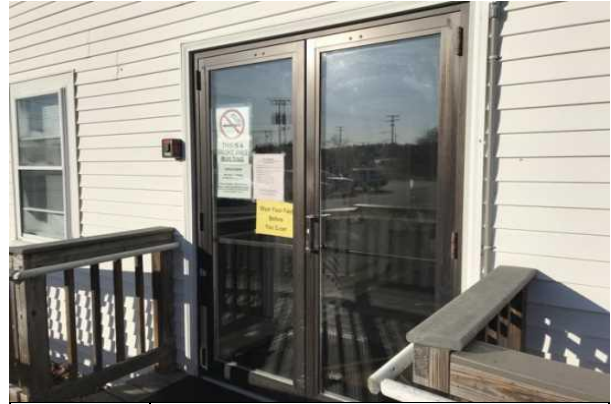
#20

EXTERIOR DOOR, ALUMINUM-  
FRAMED FULLY GLAZED

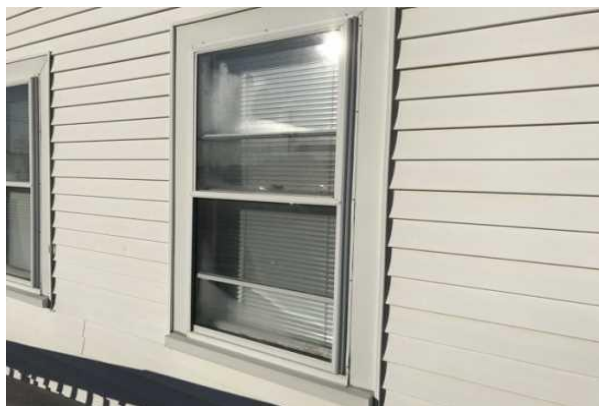
#21

STORM WINDOW SCREEN

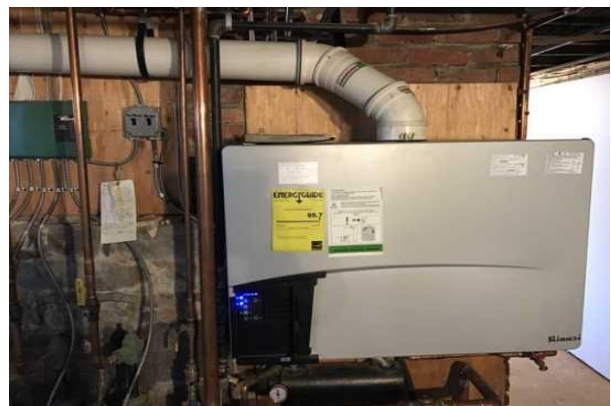
#22

BOILER, PROPANE

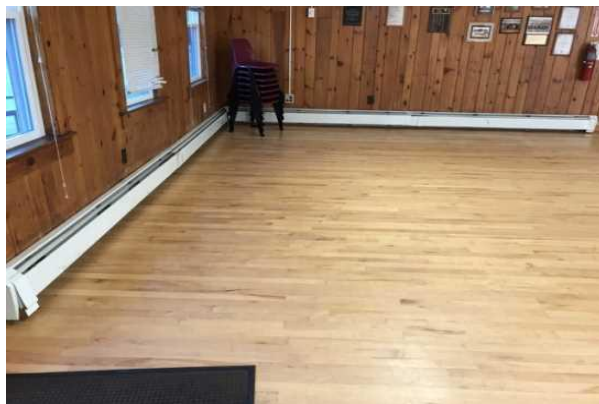
#23

The building is primarily heated by hydronic baseboard heaters and a single 175 MBH propane-fired boiler which was installed in 2013. Hydronic baseboard heaters throughout are older units, with numerous damaged casings, and should be upgraded in the near future.

RADIATOR, HYDRONIC  
BASEBOARD

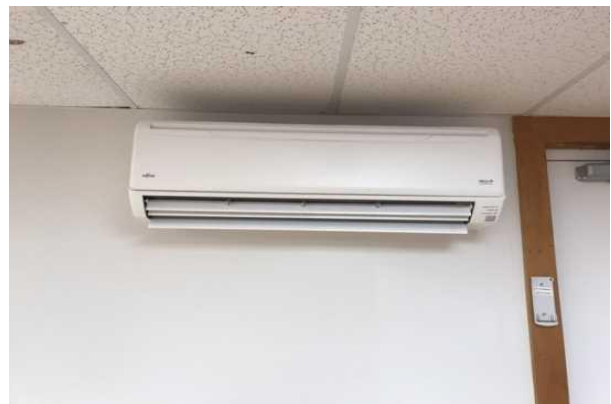
#24

DUCTLESS SPLIT SYSTEM,  
RECREATION ROOM

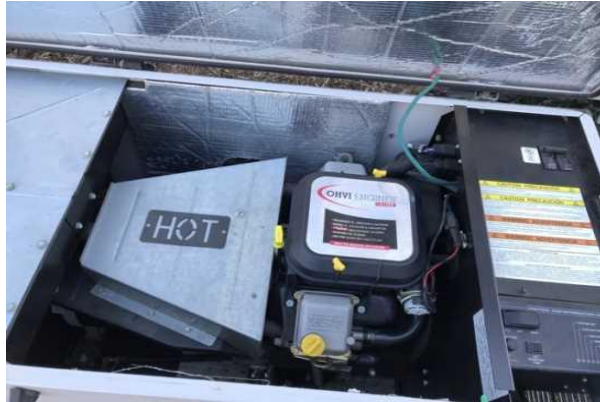
#25	GENERATOR, DIESEL
-----	-------------------

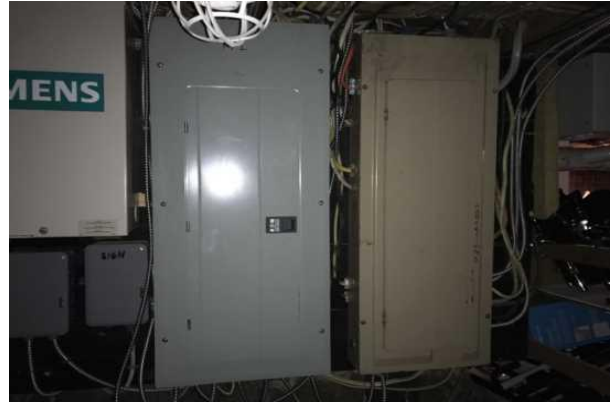
#26	ELECTRICAL DISTRIBUTION PANELS
-----	--------------------------------

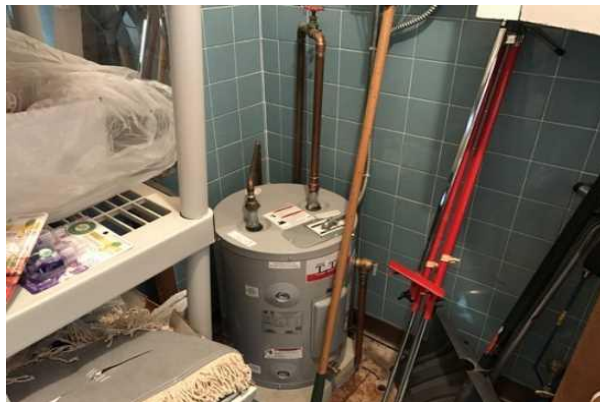
#27	WATER HEATER, ELECTRIC
-----	------------------------

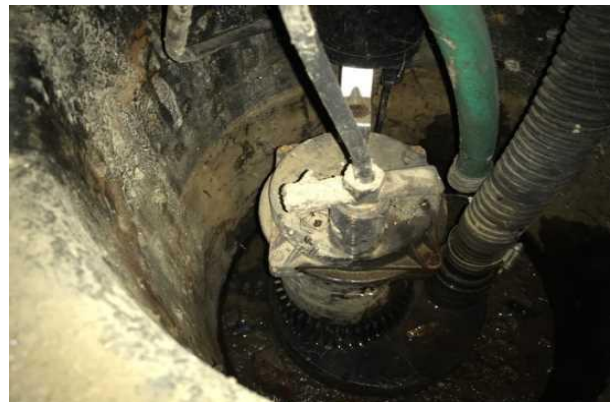
A 12-gallon electric water heater serves the two eastern bathrooms of the building. Plumbing is comprised of copper, PEX and PVC with no apparent or reported issues. A sump pump in the west portion basement is in deteriorated condition and should be replaced to prevent flooding.

#28	SUMP PUMP
-----	-----------

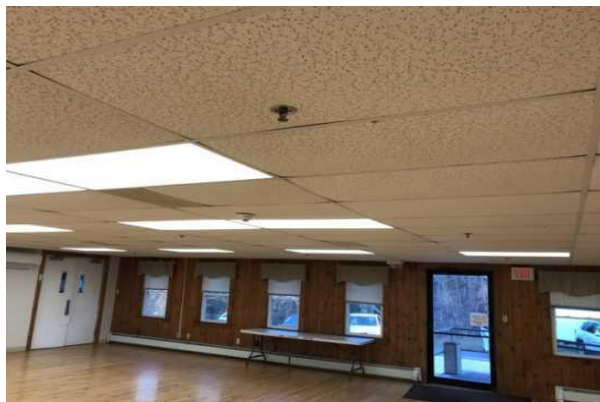
#29	SPRINKLER HEADS
-----	-----------------

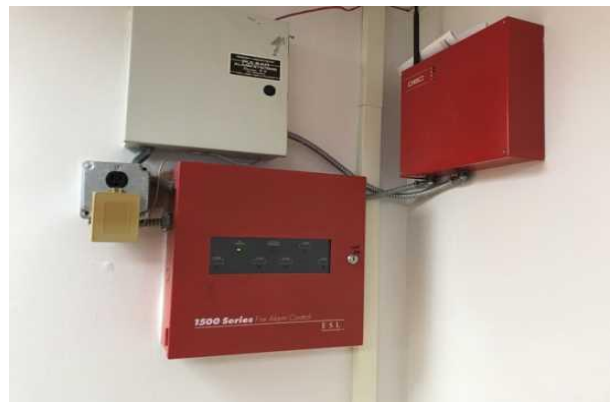
**Fire Alarm System in Poor condition.**

fire alarm fixtures are outdated and should be replaced for reliability - AssetCALC ID: 1711381

#30	FIRE ALARM CONTROL PANEL
-----	--------------------------

Uniformat Code: D5037  
Recommendation: **Upgrade/Install in 2020**

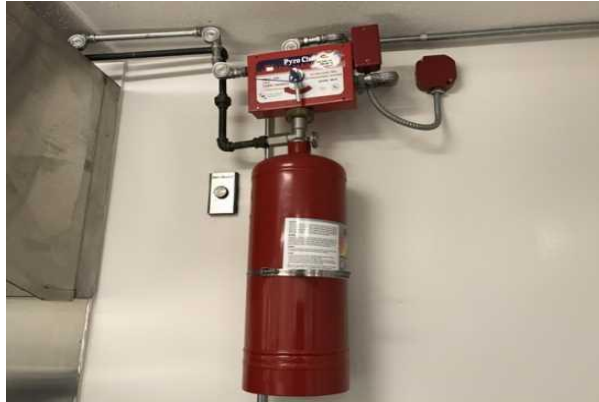
#31 FIRE SUPPRESSION SYSTEM,  
KITCHEN HOOD

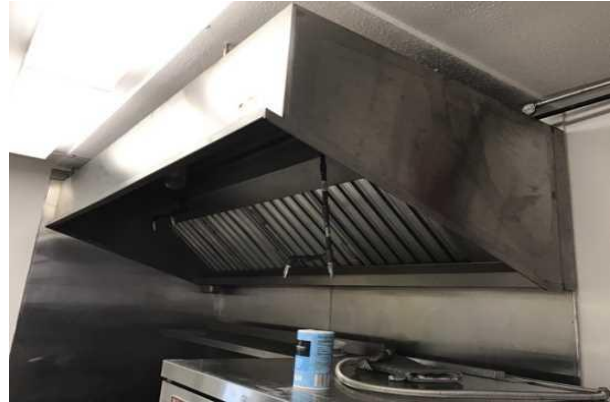
#32 COMMERCIAL KITCHEN,  
EXHAUST HOOD

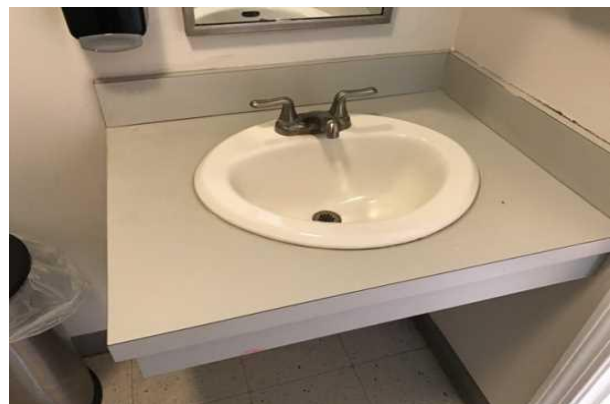
#34 SINK/LAVATORY ENAMELED  
STEEL

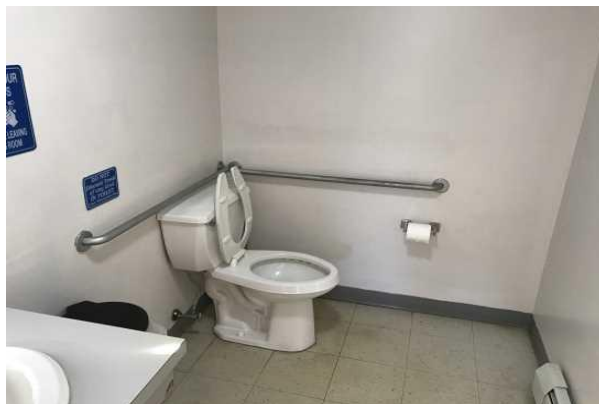
#35 TOILET, RESIDENTIAL

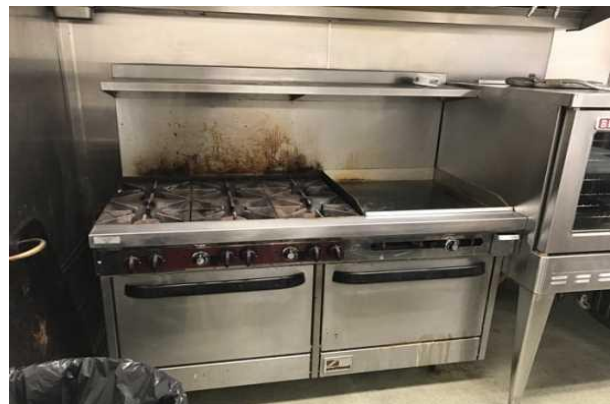
#36 COMMERCIAL KITCHEN,  
RANGE/OVEN

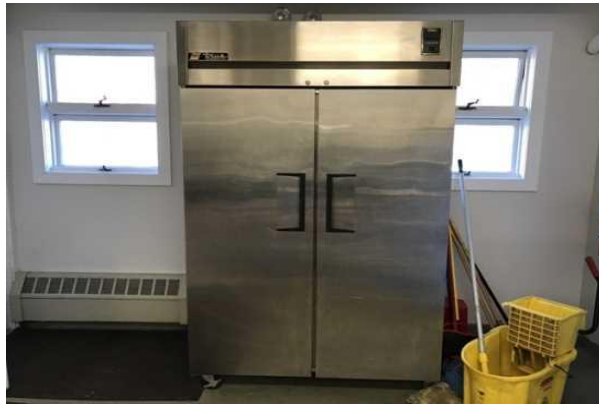
#37

COMMERCIAL KITCHEN,  
REFRIGERATOR

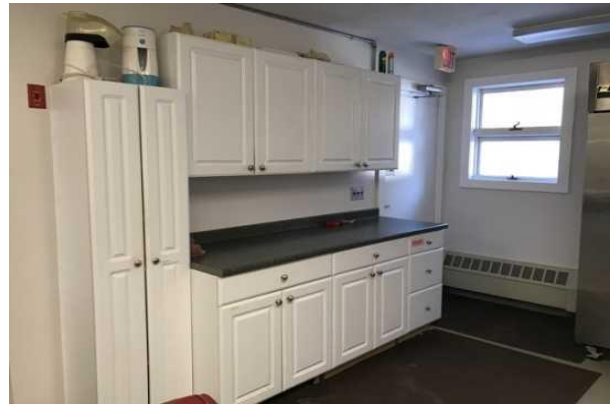
#38

KITCHEN CABINETRY, STOCK  
HARDWOOD

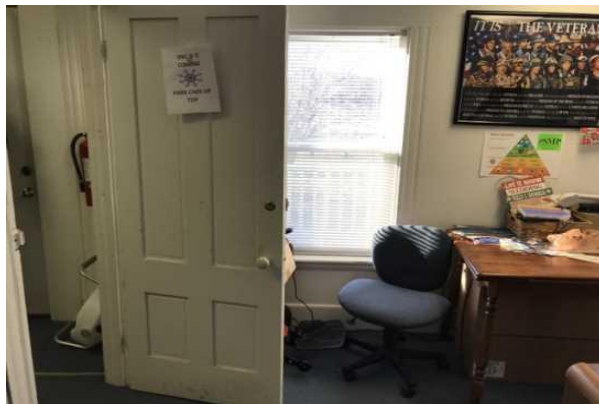
#39

INTERIOR DOOR, WOOD SOLID-  
CORE

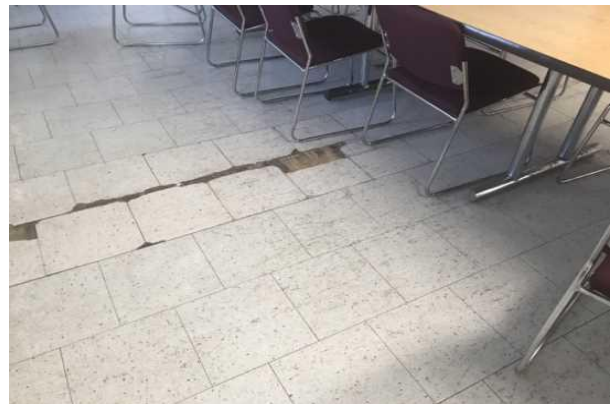
#40

INTERIOR FLOOR FINISH, VINYL  
TILE

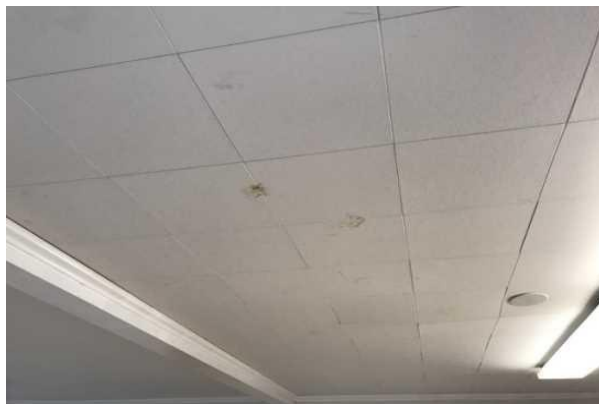
#41

SUSPECT ASBESTOS  
CONTAINING CEILING TILES

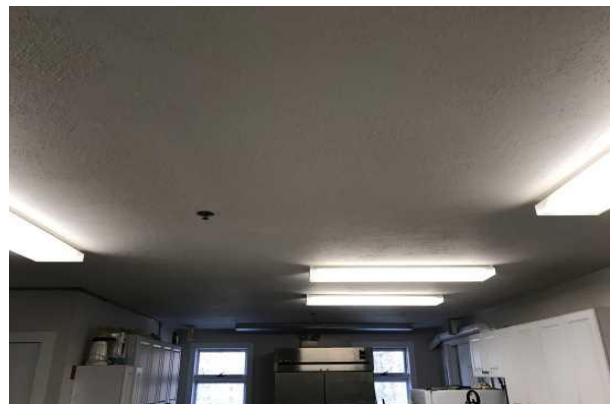
#42

INTERIOR PAINTED CEILING

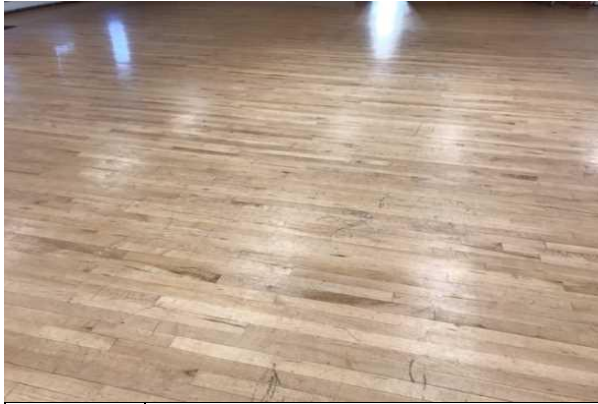
#43

INTERIOR FLOOR FINISH,  
SPORTS FLOOR

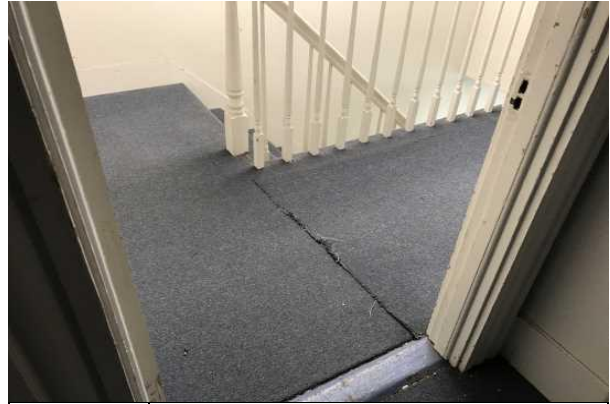
#44

INTERIOR FLOOR FINISH,  
COMMERCIAL CARPET

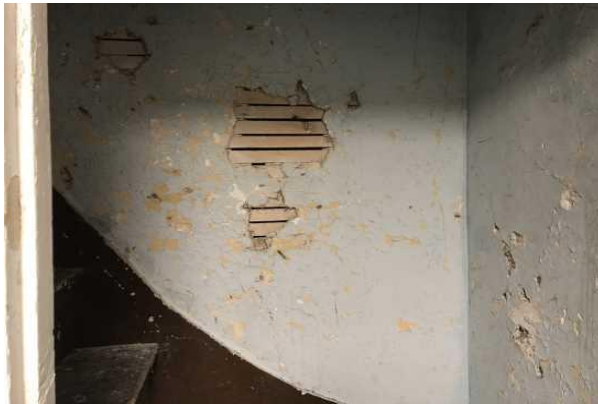
#45

SUSPECT LEAD PAINT

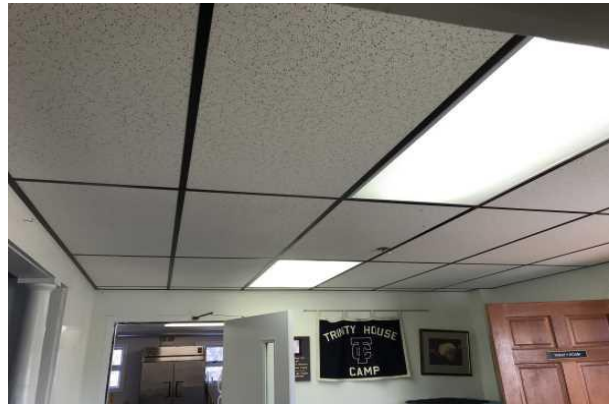
#46

INTERIOR CEILING FINISH,  
SUSPENDED ACOUSTICAL TILE

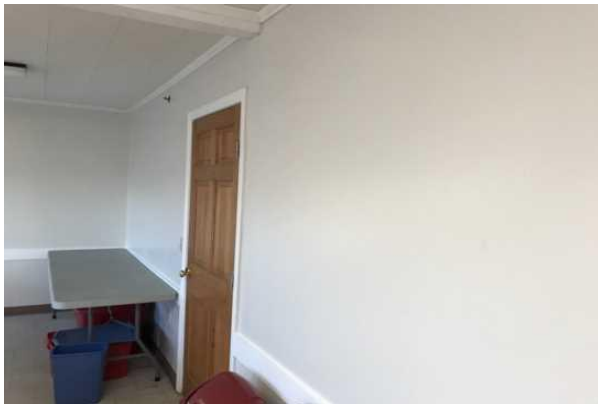
#47

INTERIOR PAINTED WALL FINISH

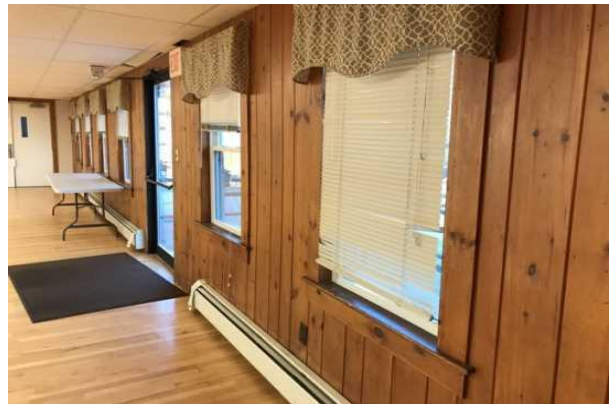
#48

INTERIOR WALL FINISH, WOOD  
PANEL

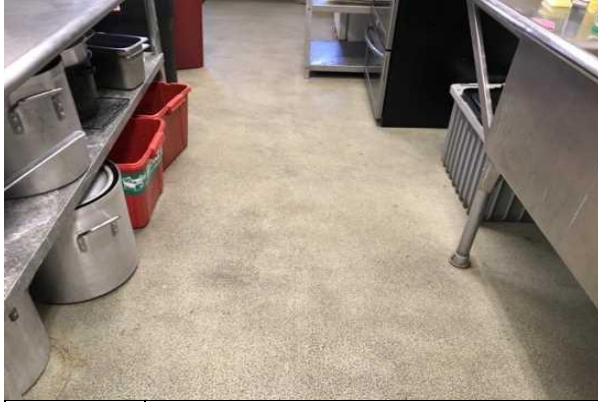
#49

INTERIOR FLOOR FINISH,  
TERRAZZO

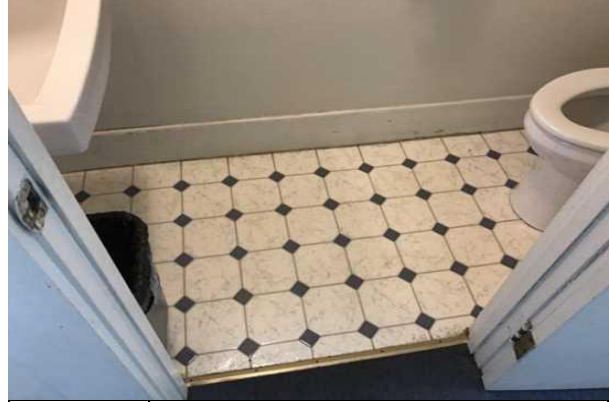
#50

INTERIOR FLOOR FINISH, VINYL  
SHEETING
