# FACILITY CONDITION ASSESSMENT

## TOWN OF ATKINSON

## COMMUNITY CENTER

4 Main Street  
Atkinson, New Hampshire 03814

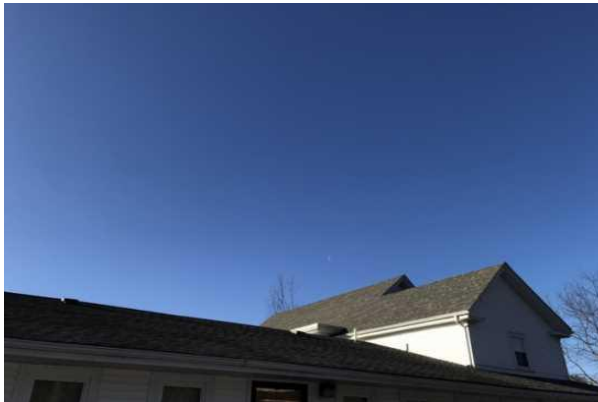
#15 ROOF, ASPHALT SHINGLE

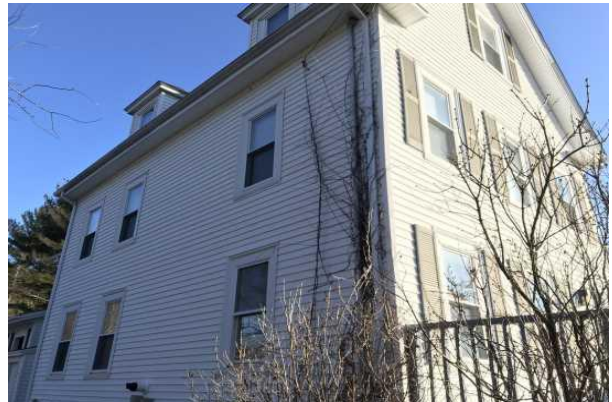
#16 EXTERIOR WALL, VINYL SIDING

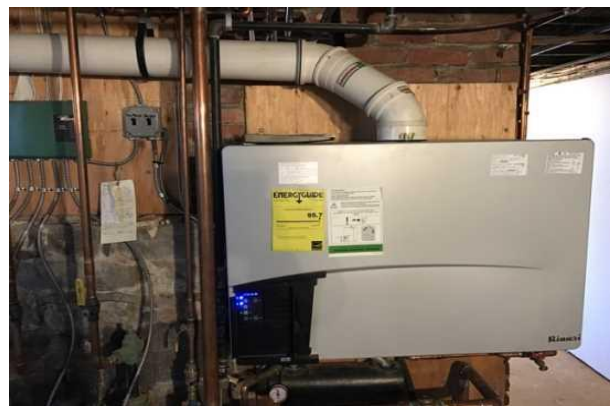
#22

The building is primarily heated by hydronic baseboard heaters and a single 175 MBH propane-fired boiler which was installed in 2013. Hydronic baseboard heaters throughout are older units, with numerous damaged casings, and should be upgraded in the near future.

BOILER, PROPANE

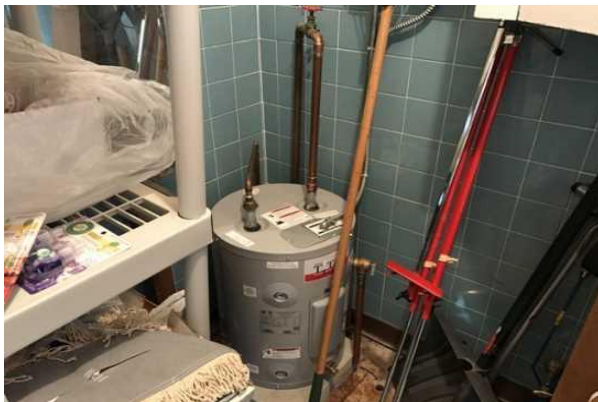
| #27 | WATER HEATER, ELECTRIC |

A 12-gallon electric water heater serves the two eastern bathrooms of the building. Plumbing is comprised of copper, PEX and PVC with no apparent or reported issues. A sump pump in the west portion basement is in deteriorated condition and should be replaced to prevent flooding.

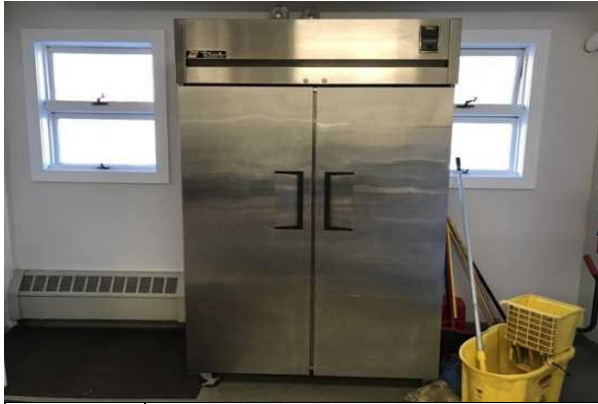
#37

COMMERCIAL KITCHEN,  
REFRIGERATOR

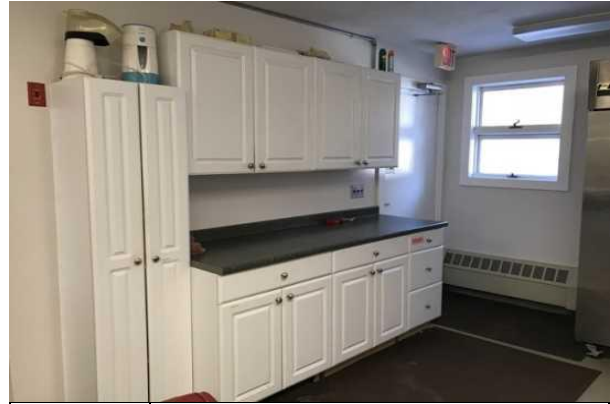
#38

KITCHEN CABINETRY, STOCK  
HARDWOOD

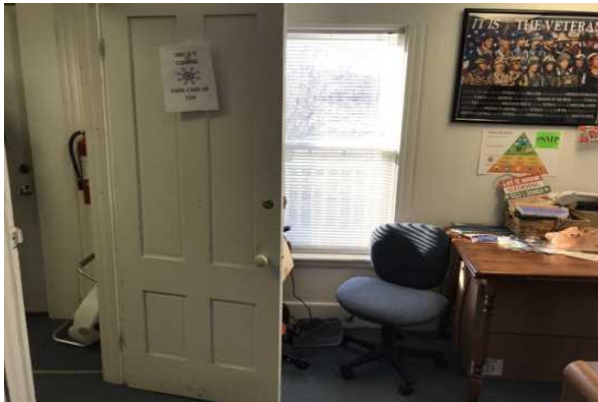
#39

INTERIOR DOOR, WOOD SOLID-  
CORE

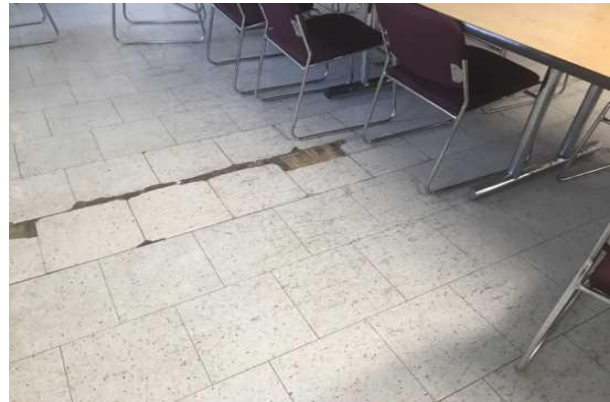
#40

INTERIOR FLOOR FINISH, VINYL  
TILE

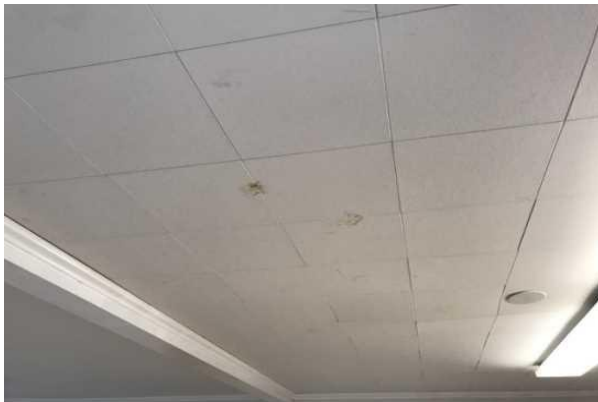
#41

SUSPECT ASBESTOS  
CONTAINING CEILING TILES

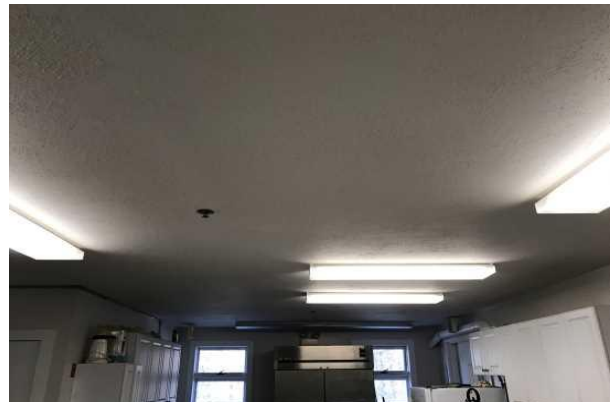
#42

INTERIOR PAINTED CEILING

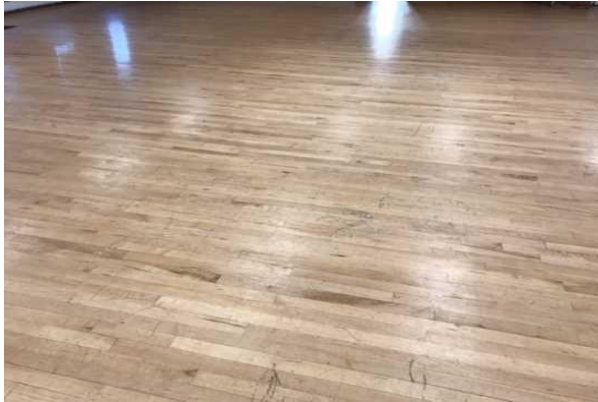
#43

INTERIOR FLOOR FINISH,  
SPORTS FLOOR

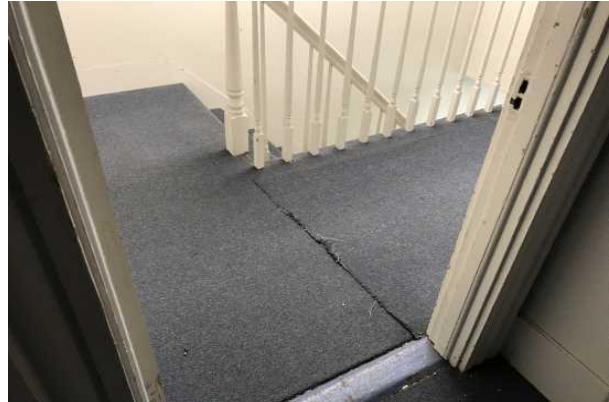
#44

INTERIOR FLOOR FINISH,  
COMMERCIAL CARPET

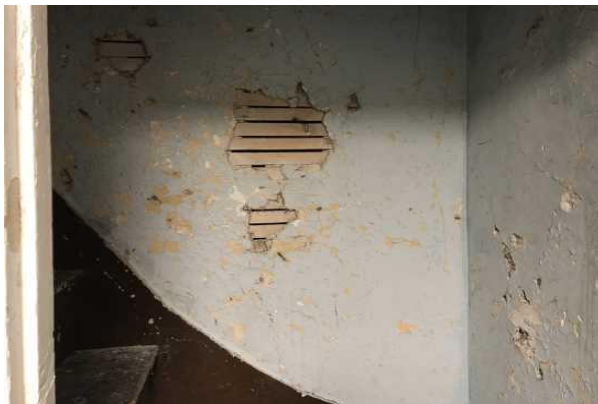
#45

SUSPECT LEAD PAINT

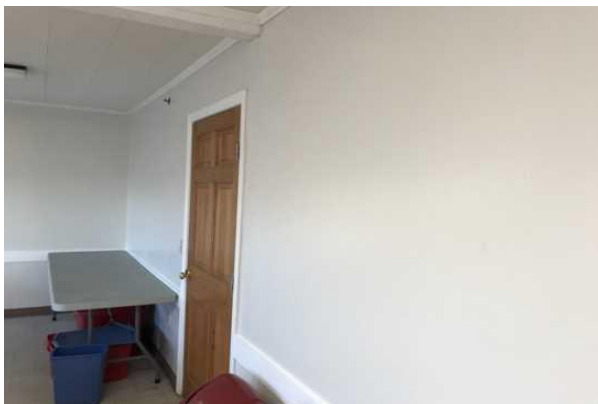
#47

INTERIOR PAINTED WALL FINISH

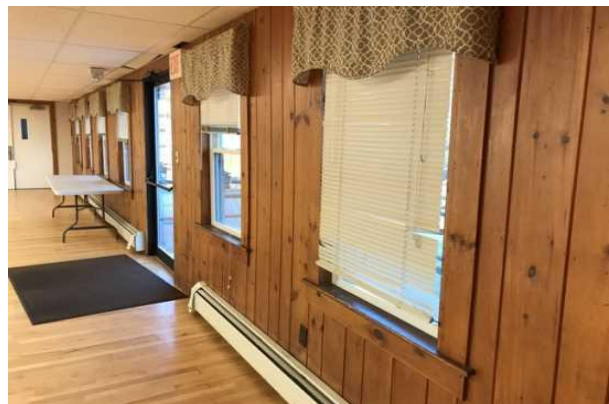
#48

INTERIOR WALL FINISH, WOOD  
PANEL
